# **Junior Aerial Thermal Survey Report**

**URN:** **JA-20072026-0001**

**Junior Aerial has approached Escot House and have offered to conduct a thermal roof survey.**

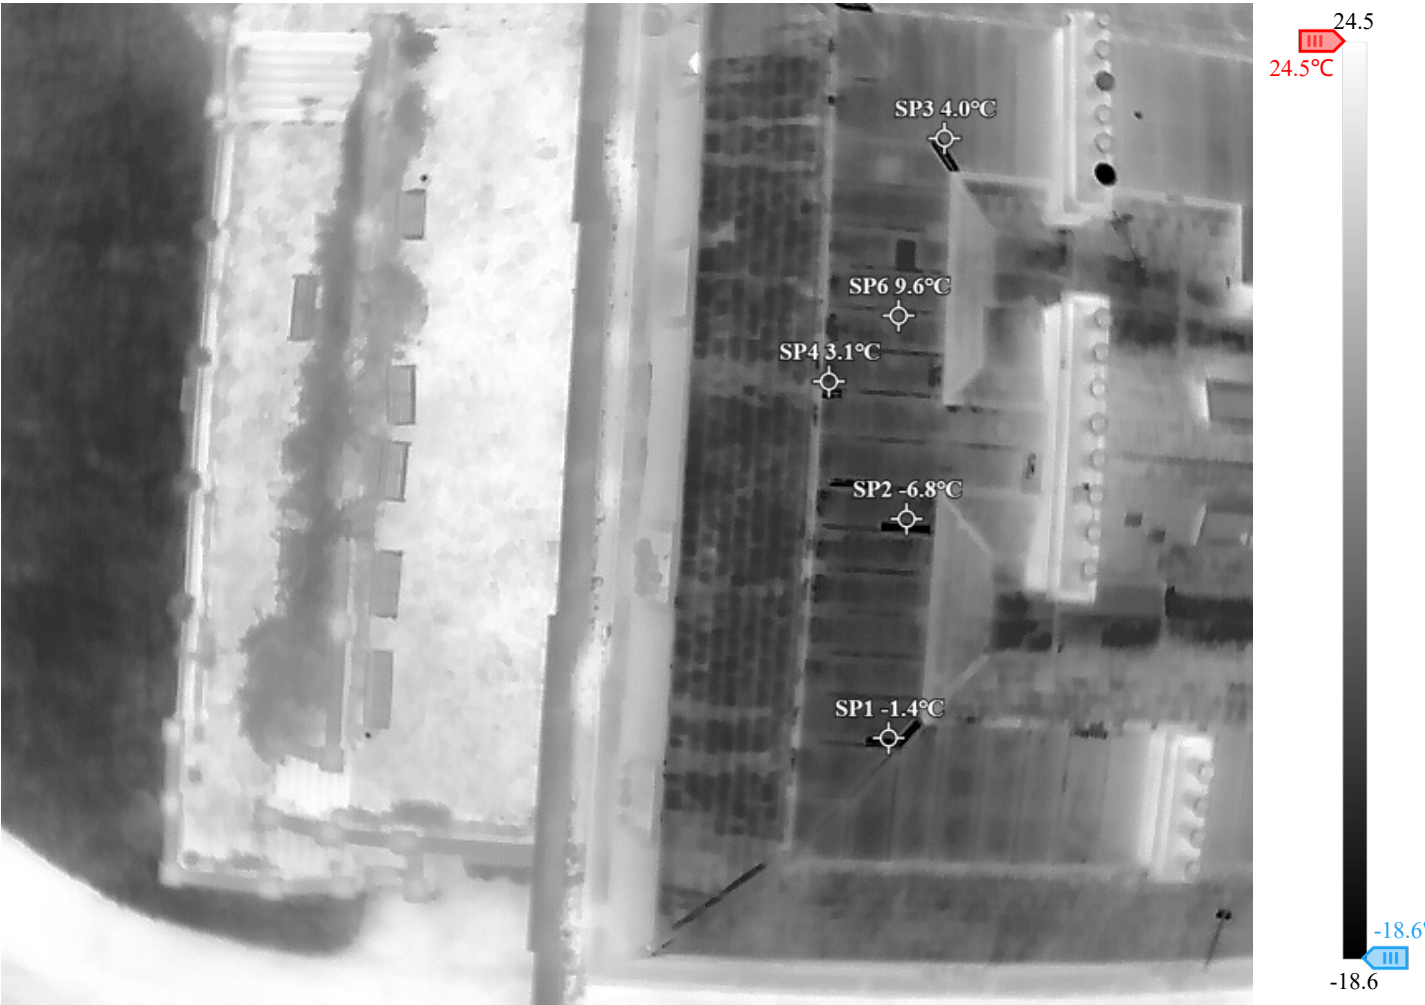
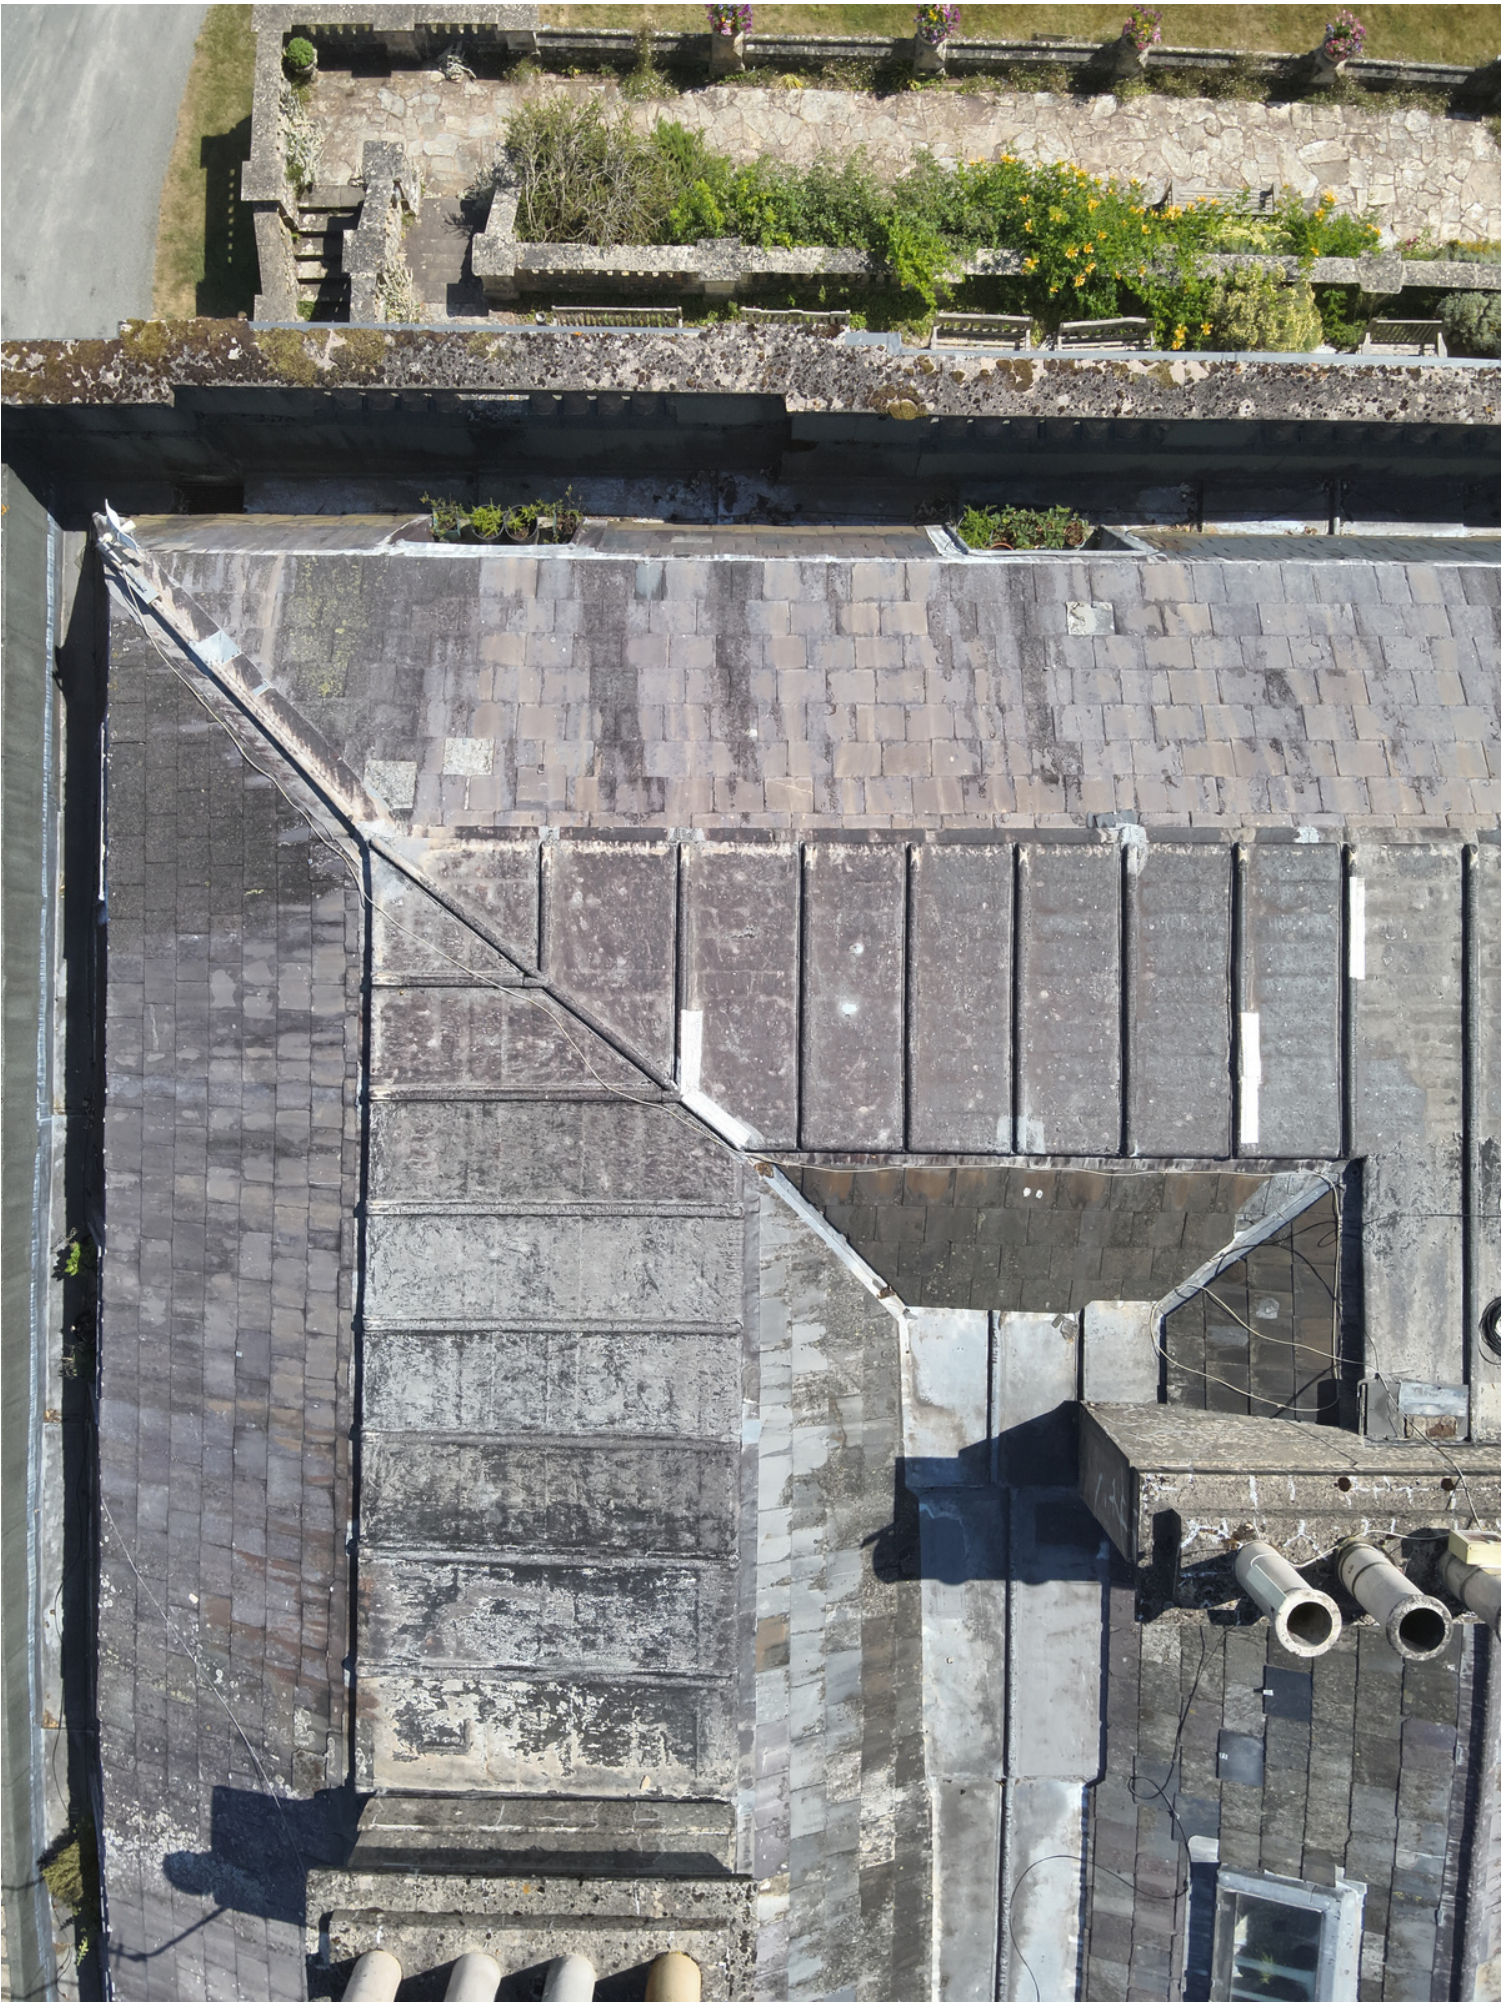
DJI\_20260720220141\_0004\_T.JPG

Anomalies identified between survey points SP1/SP6 and the surrounding roof structure, with a maximum observed differential of approximately 16.4°C.

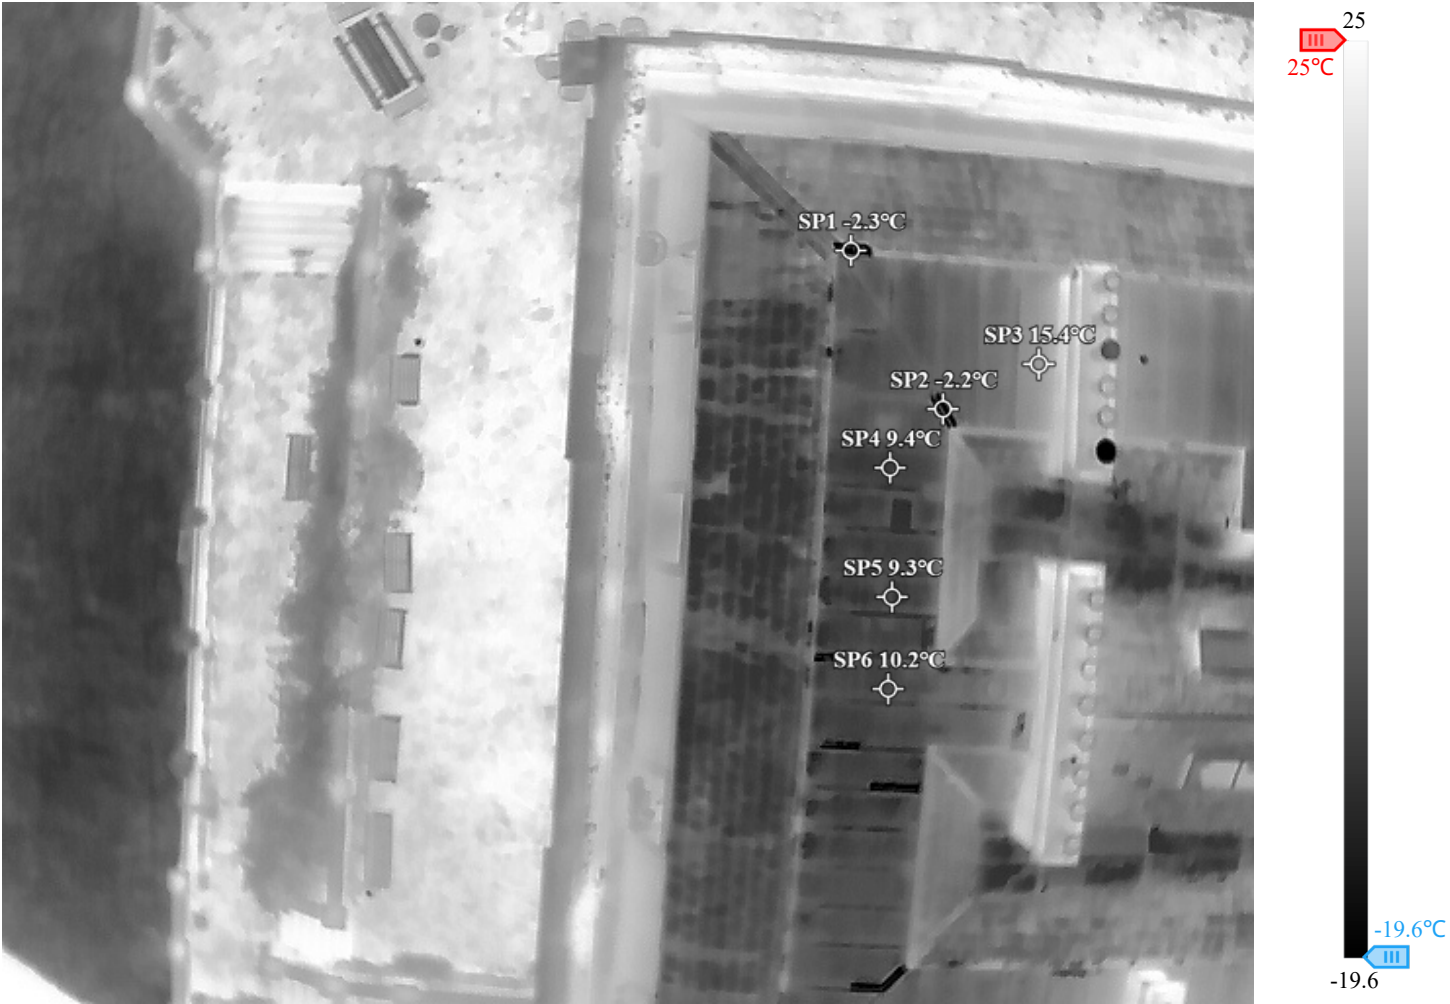
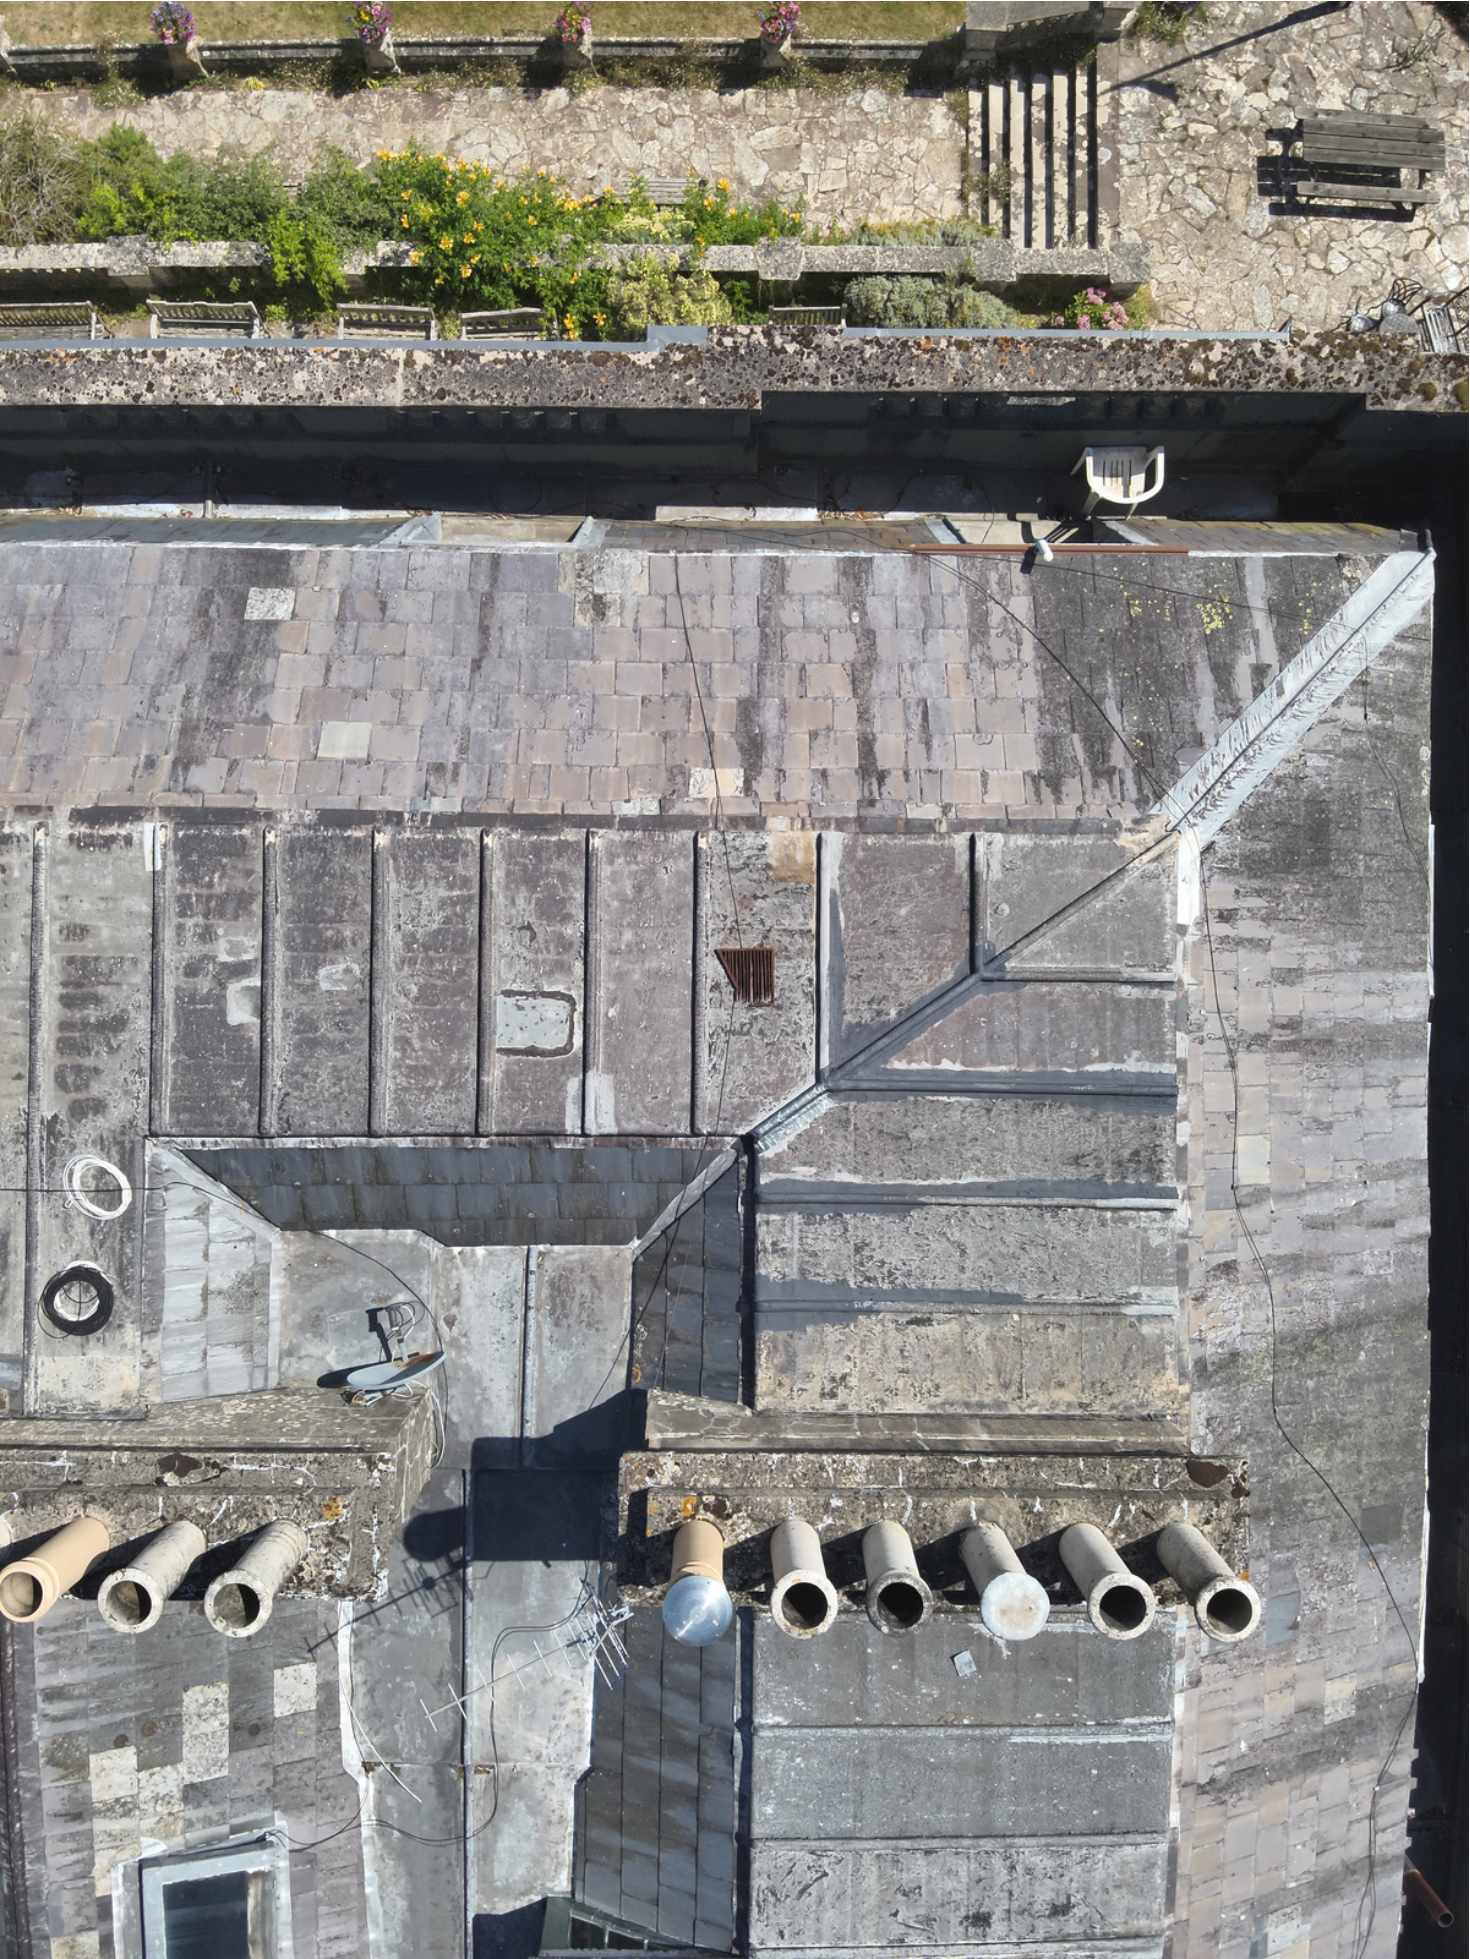
DJI\_20260720220146\_0005\_T.JPG

Anomalies identified between survey points SP1/SP6 and the surrounding roof structure, with a maximum observed differential of approximately 17.7°C.

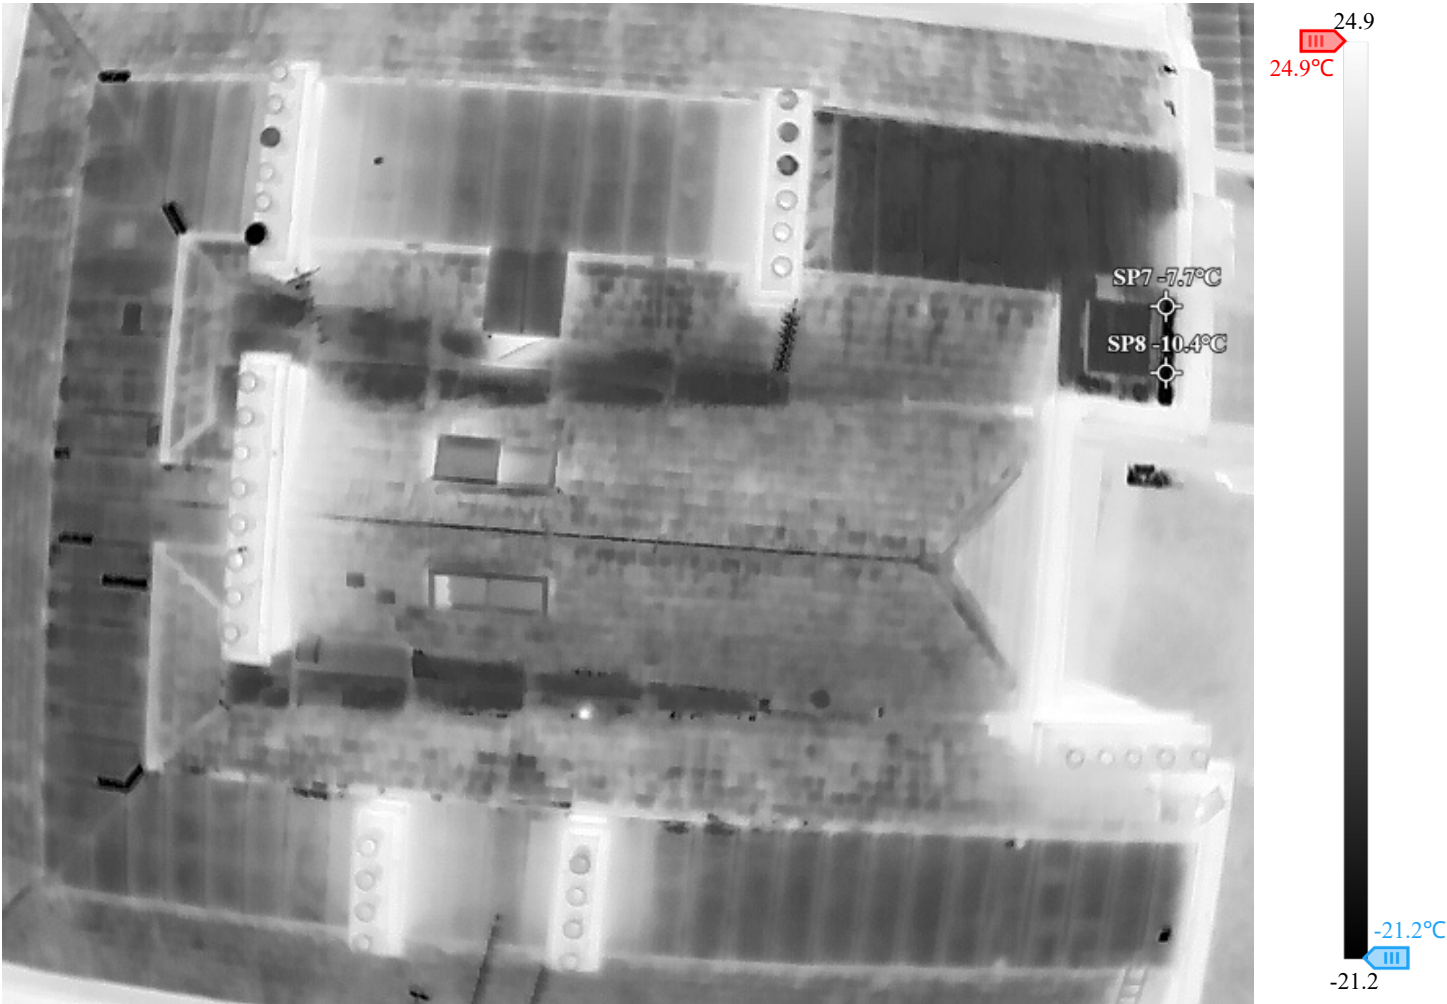
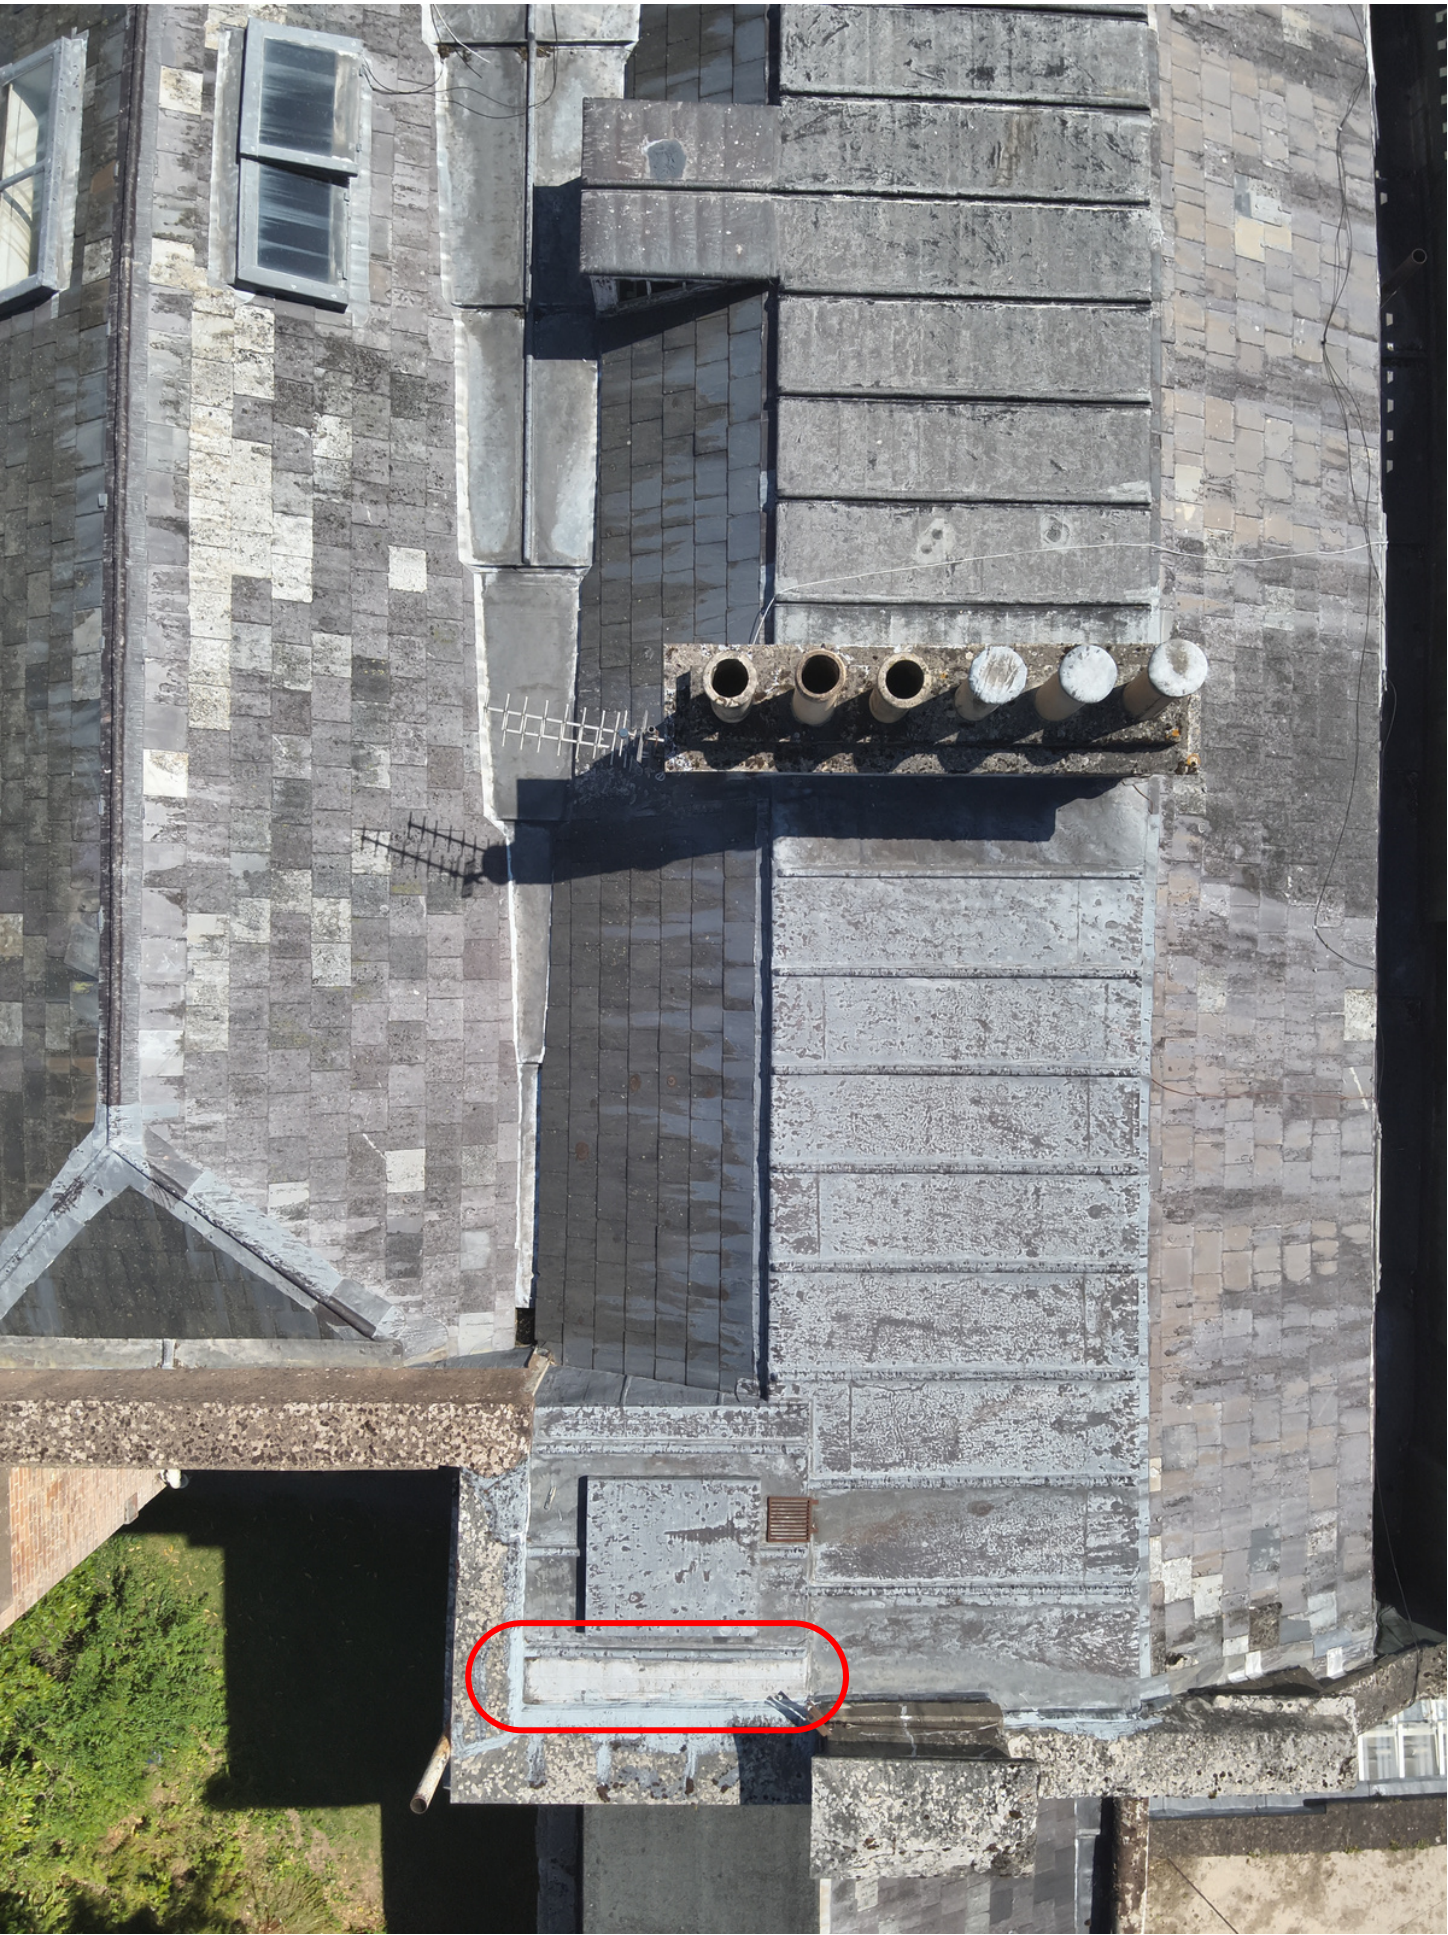
DJI\_20260720220310\_0022\_T.JPG

Anomalies identified between survey points SP1/SP6 and the surrounding roof structure, with a maximum observed differential of approximately 2.7°C.
