# **Junior Aerial Thermal Survey Report**

**URN:** **JA-14072026-0001**

**Client has reported that they are looking to replace the roof of Ottery St Mary Parish Church. Junior Aerial have offered to conduct a thermal roof survey of the property to identify priority areas for inspection.**

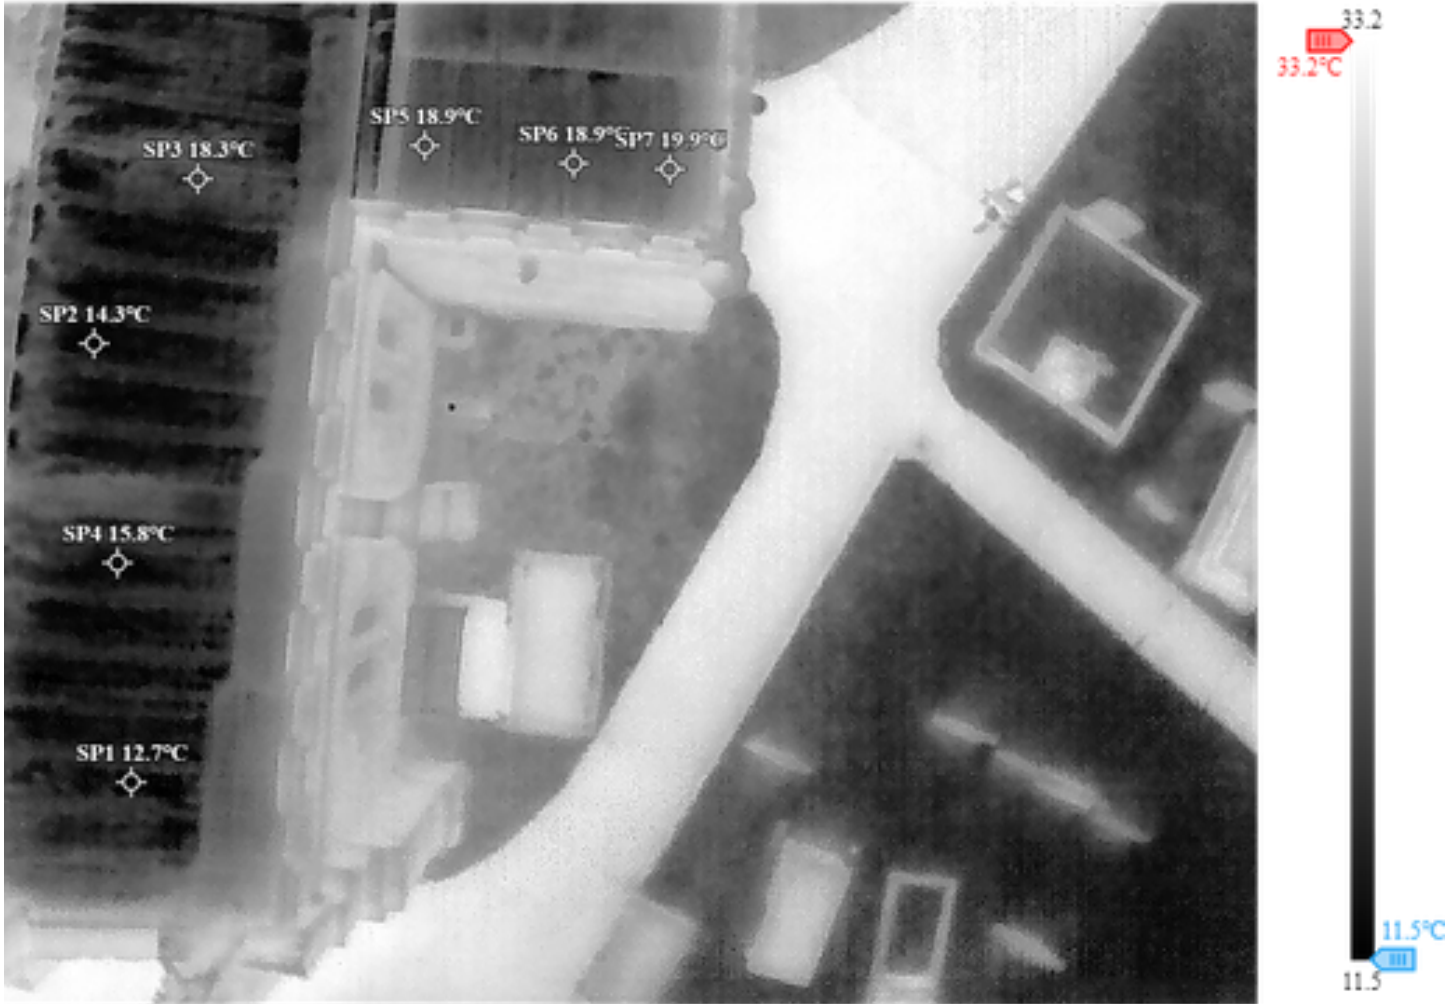
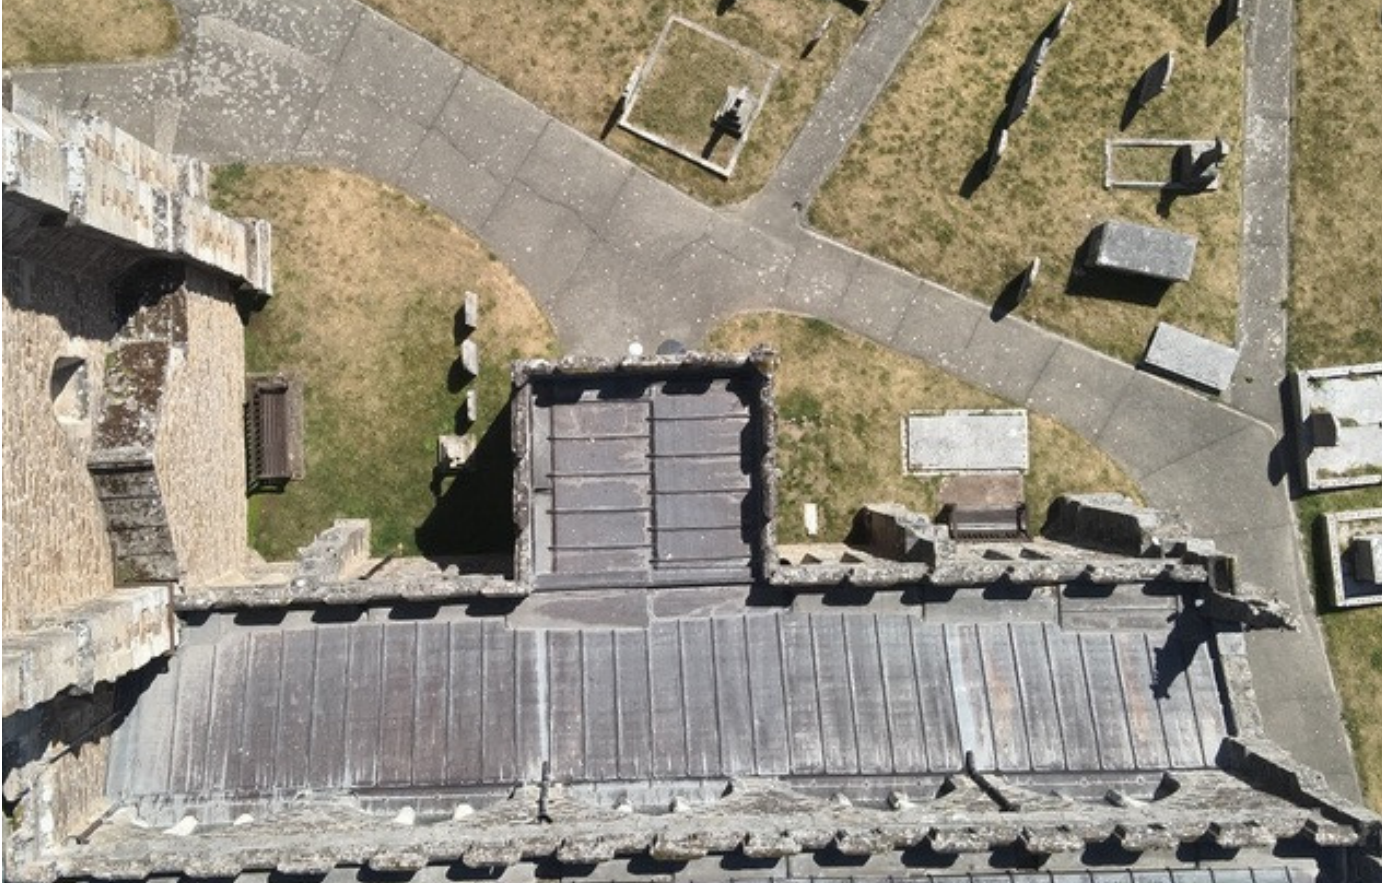
Anomalies identified between survey points SP1/SP7 and the surrounding roof structure, with a maximum observed differential of approximately 7.2°C. This area is recommended for further inspection.

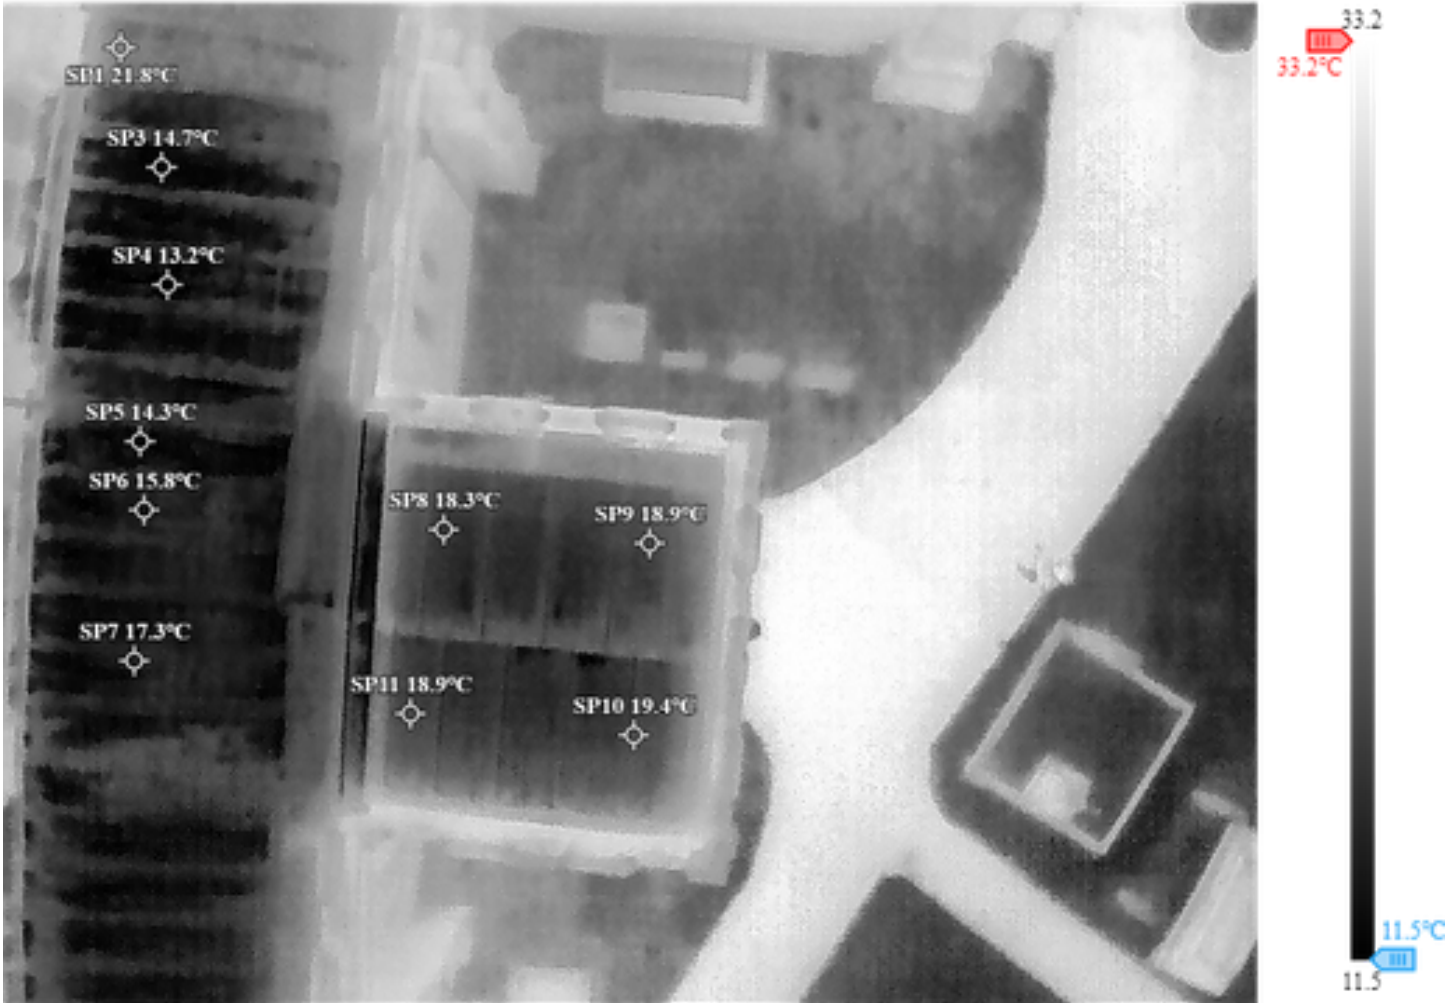
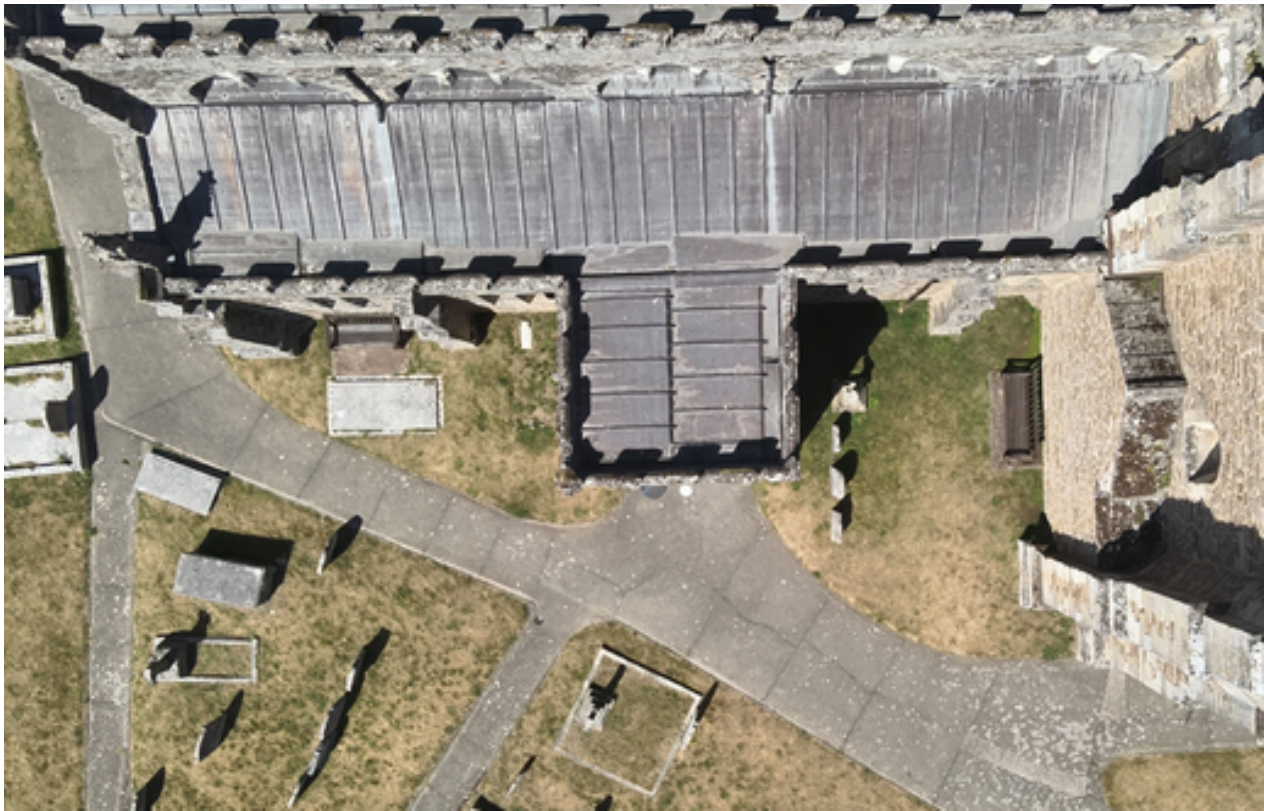
DJI\_20260714221101\_0018\_T.JPG  
2026/07/14 22:11:01

Anomalies identified between survey points SP1/SP11 and the surrounding roof structure, with a maximum observed differential of approximately 8.6°C. This area is recommended for further inspection.

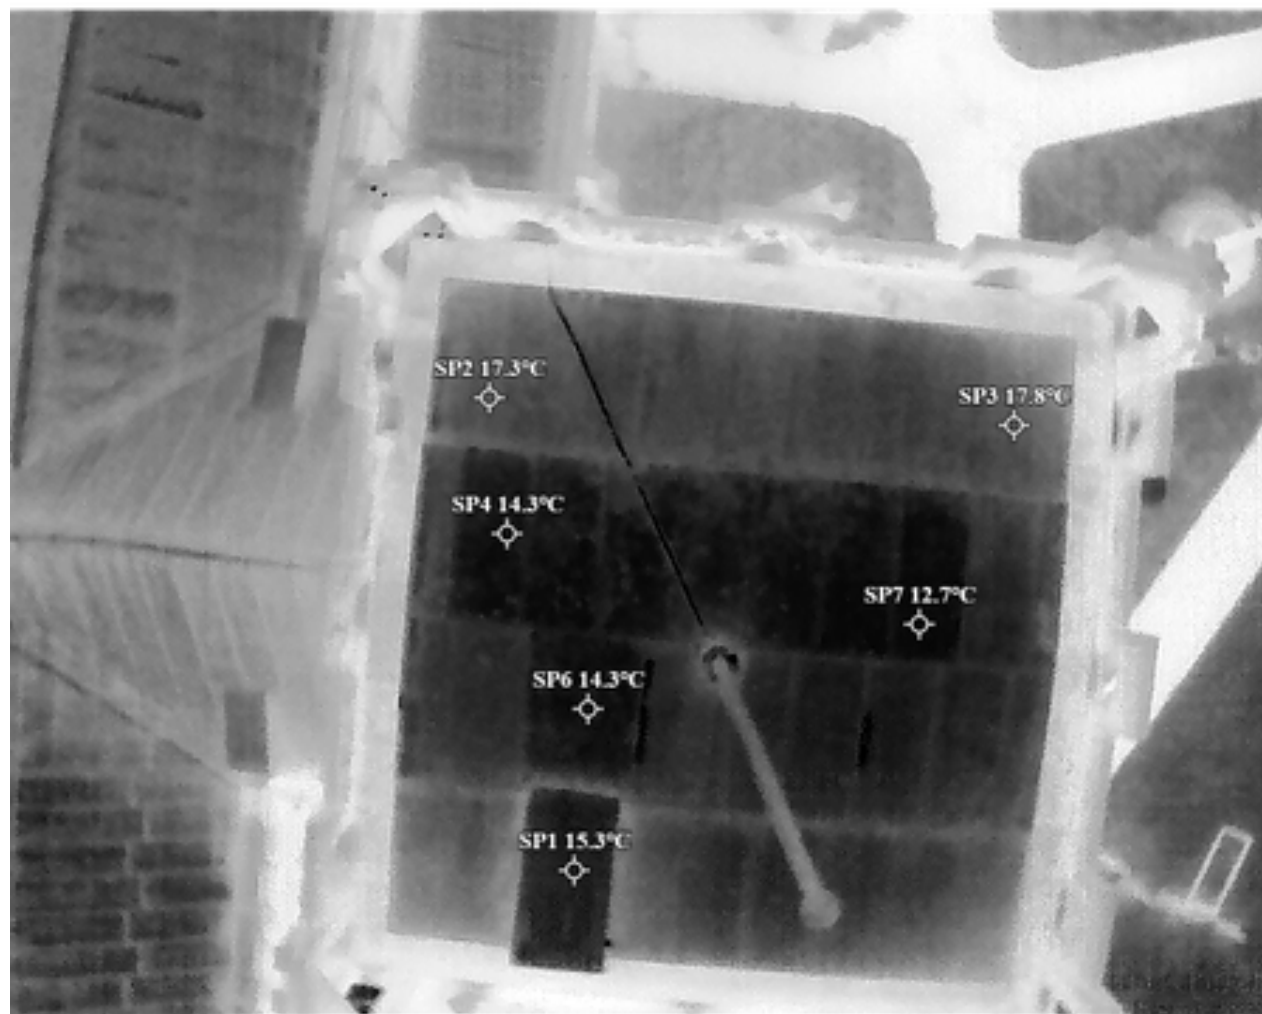
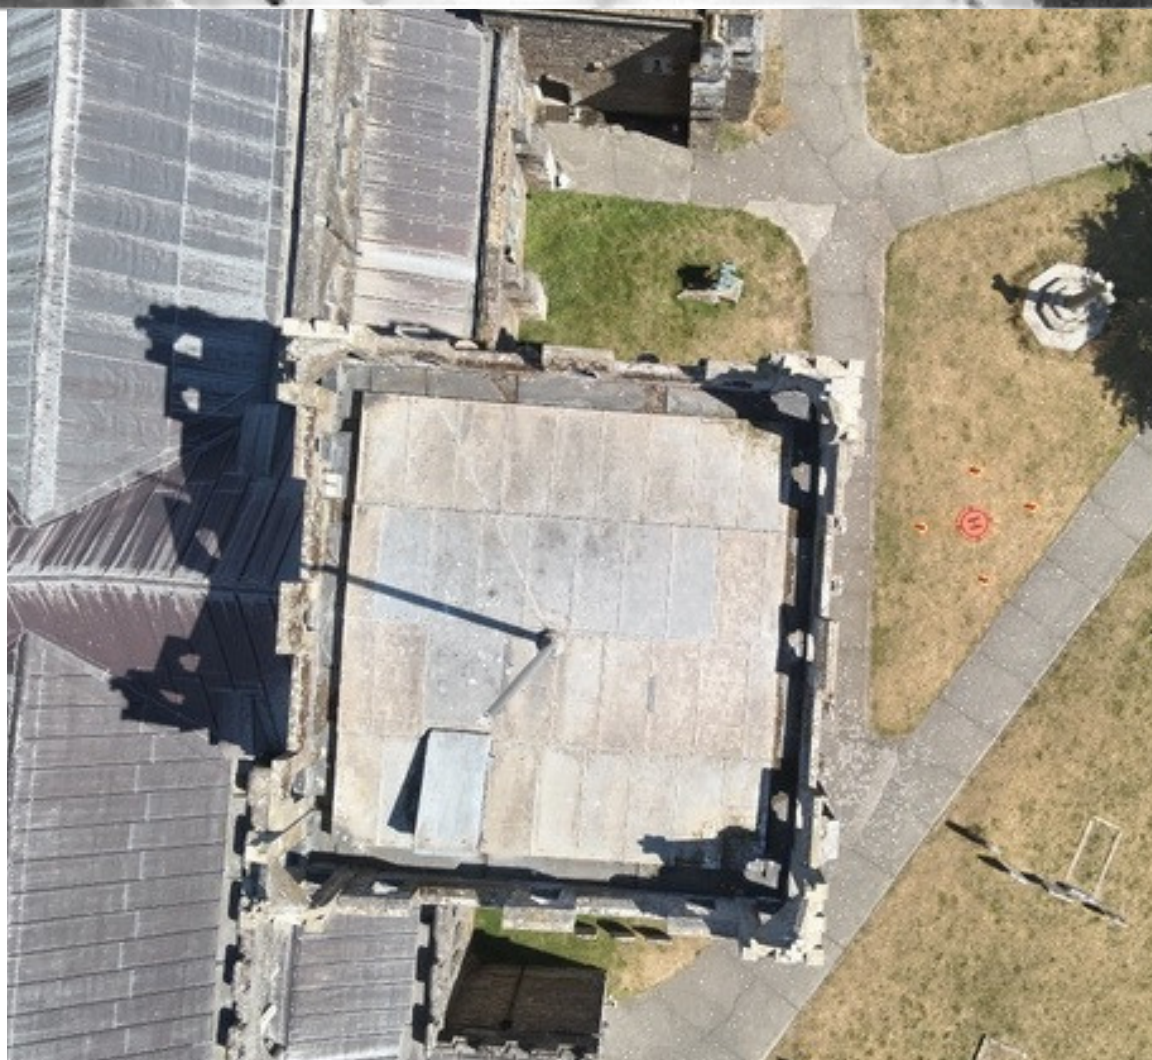
Anomalies identified between survey points SP1/SP7 and the surrounding roof structure, with a maximum observed differential of approximately 4.6°C. This area is recommended for further inspection.

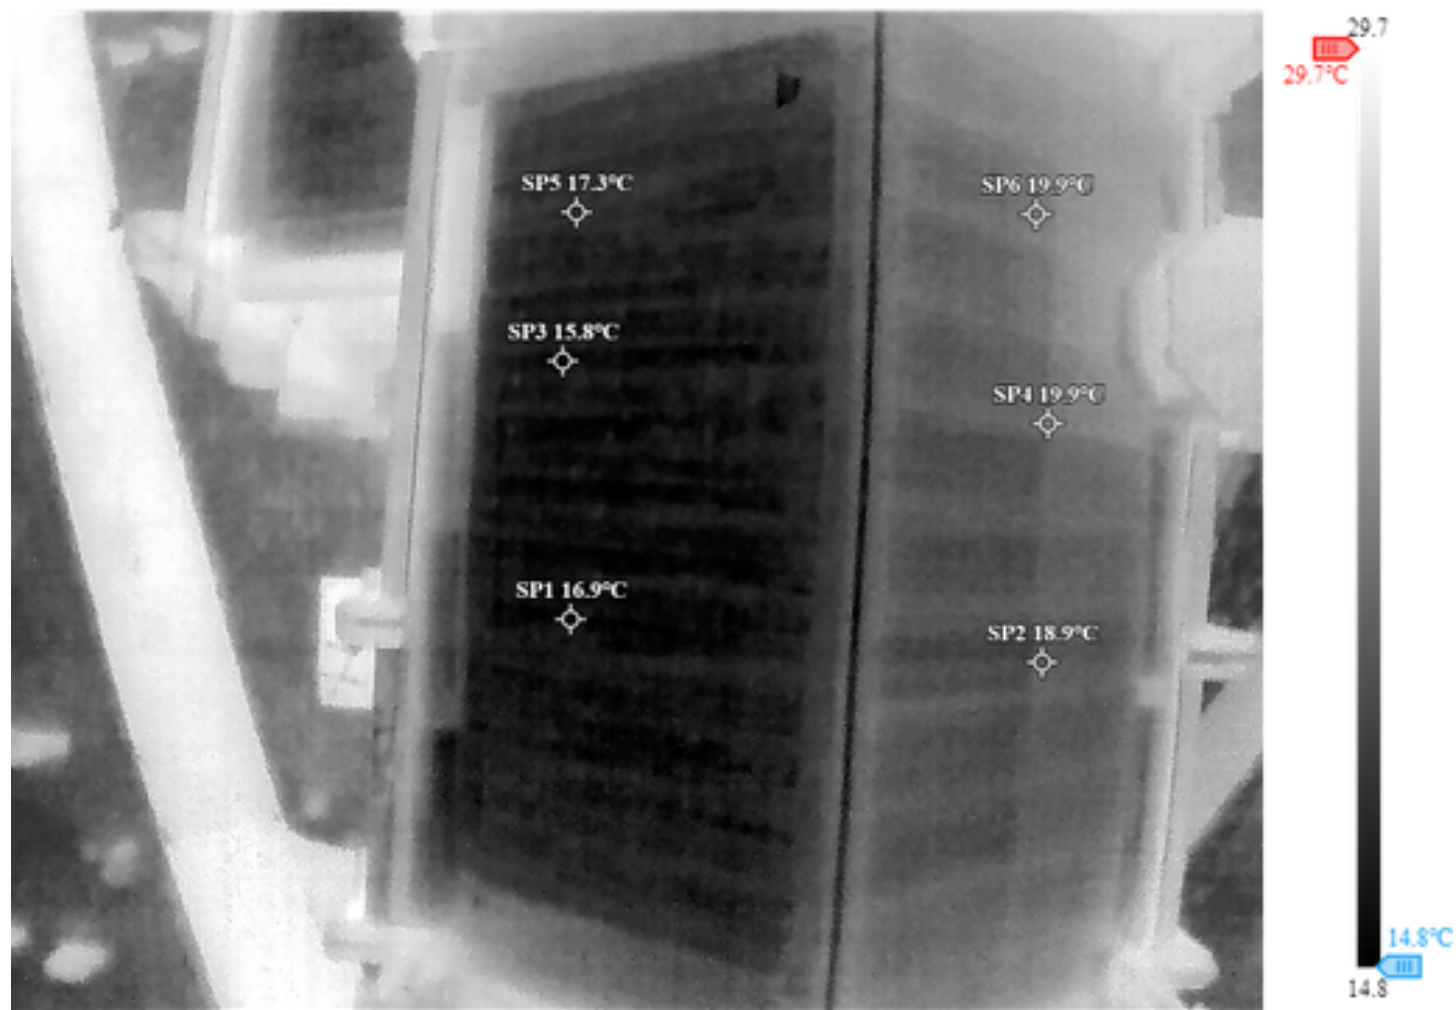
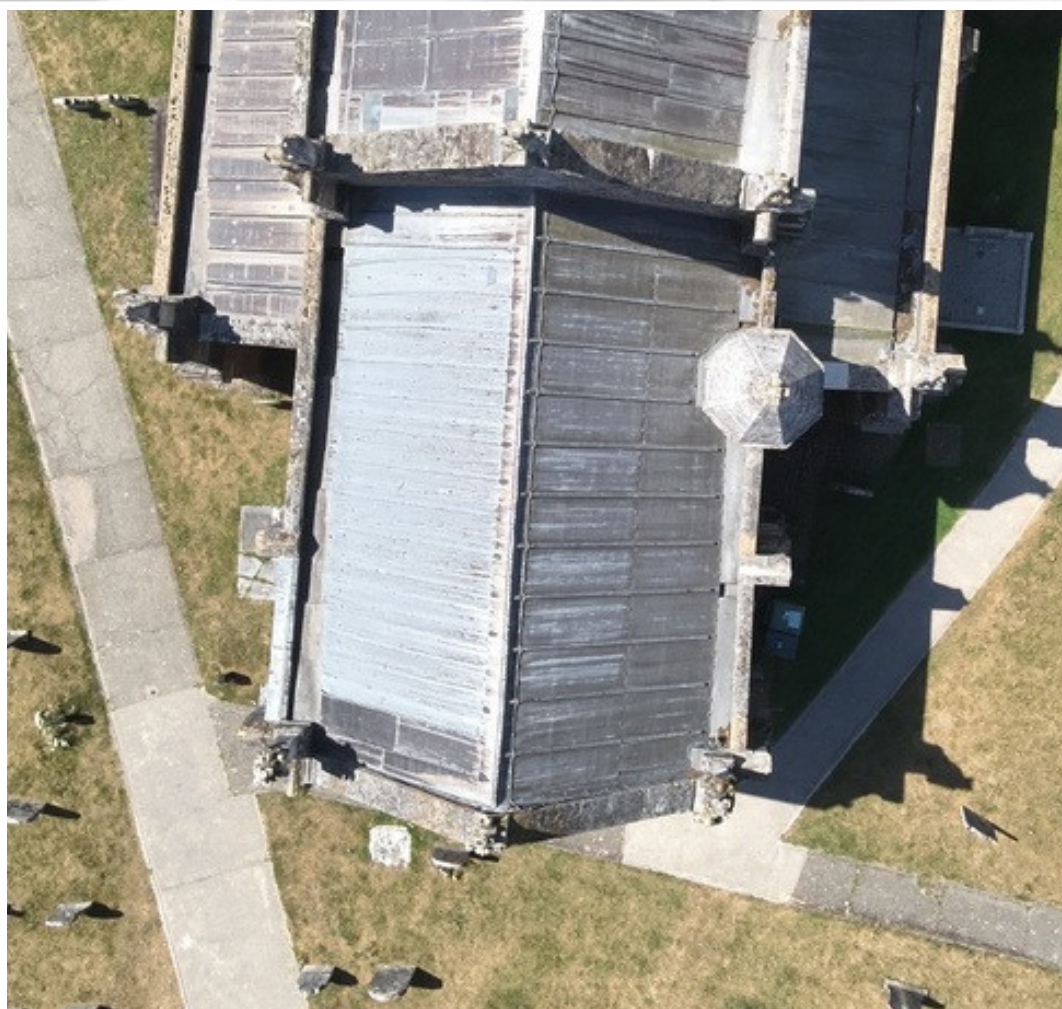
Anomalies identified between survey points SP1/SP7 and the surrounding roof structure, with a maximum observed differential of approximately 4.1°C. This area is recommended for further inspection.

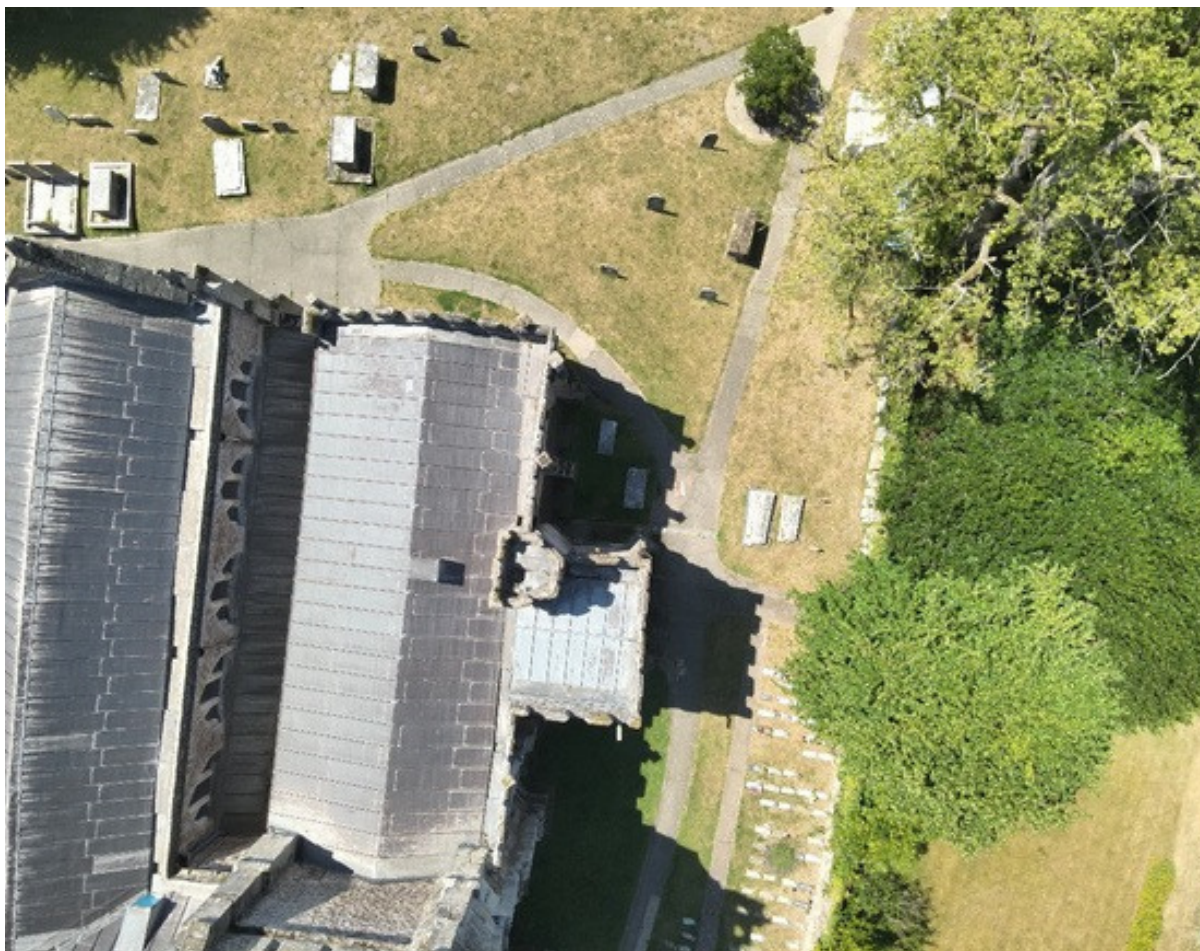
Anomalies identified between survey points SP1/SP8 and the surrounding roof structure, with a maximum observed differential of approximately 4.2°C. This area is recommended for further inspection.

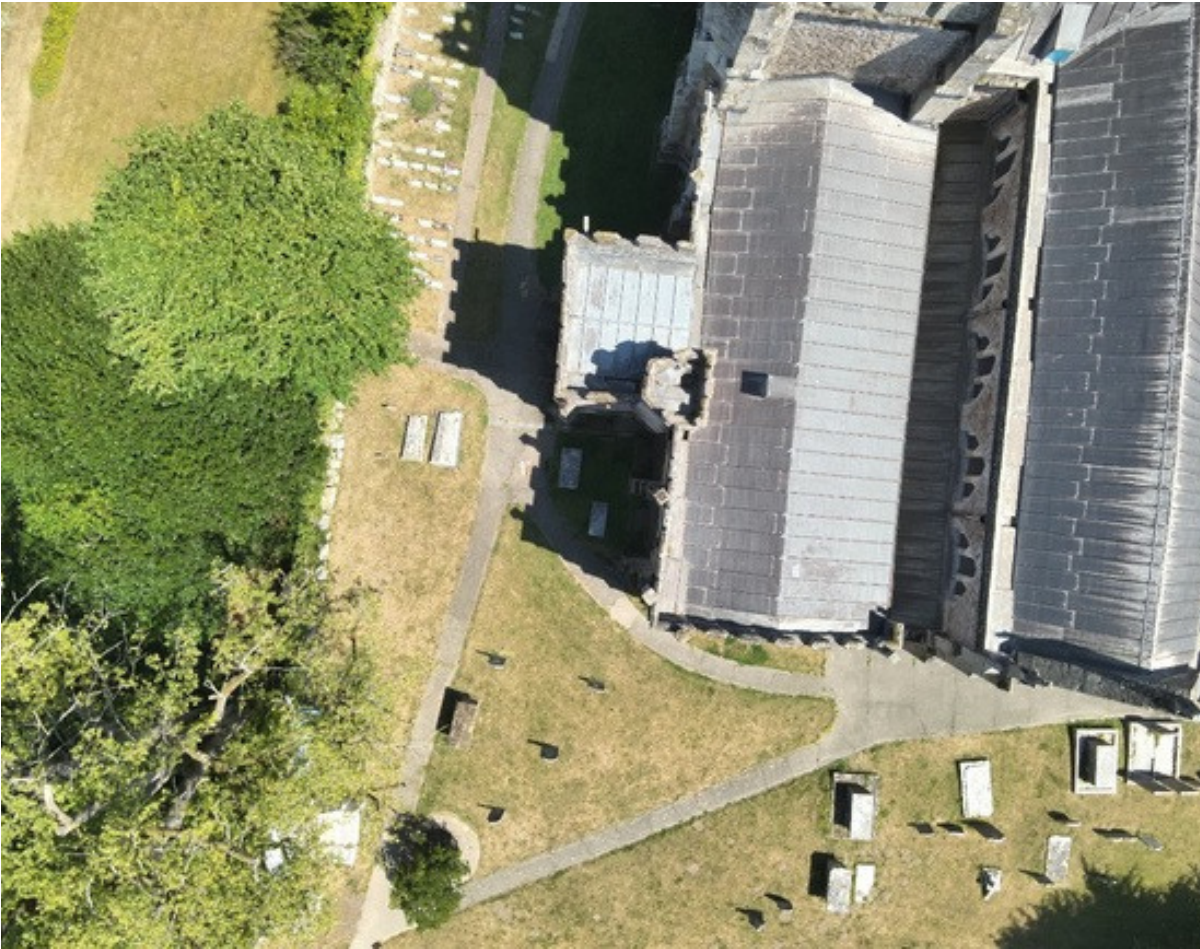
Anomalies identified between survey points SP1/SP5 and the surrounding roof structure, with a maximum observed differential of approximately 8.1°C. This area is recommended for further inspection.

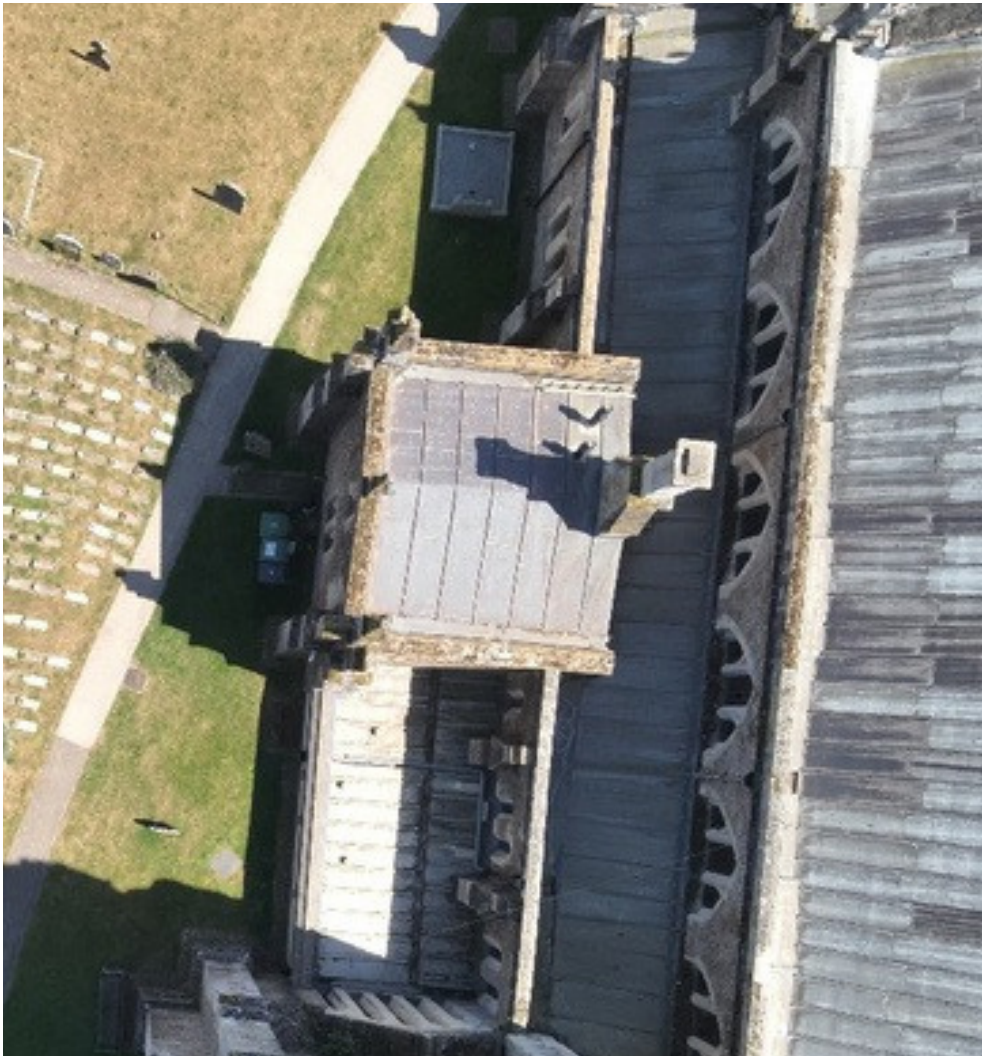
Anomalies identified between survey points SP1/SP5 and the surrounding roof structure, with a maximum observed differential of approximately 6.8°C. This area is recommended for further inspection.

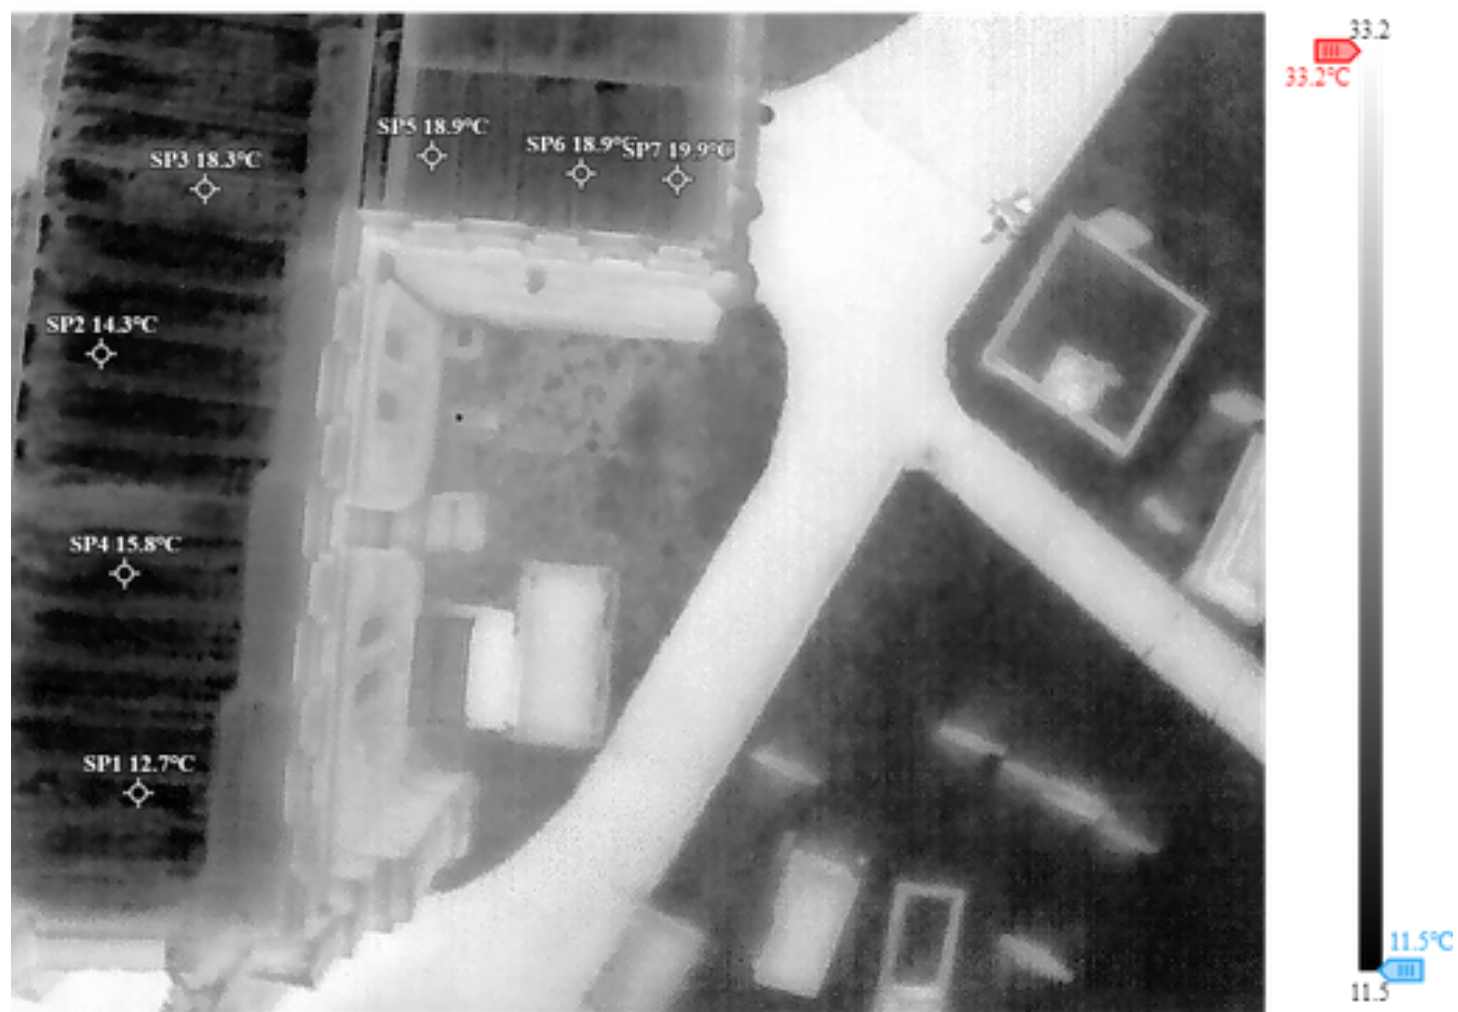
Anomalies identified between survey points SP1/SP7 and the surrounding roof structure, with a maximum observed differential of approximately 7.2°C. This area is recommended for further inspection.

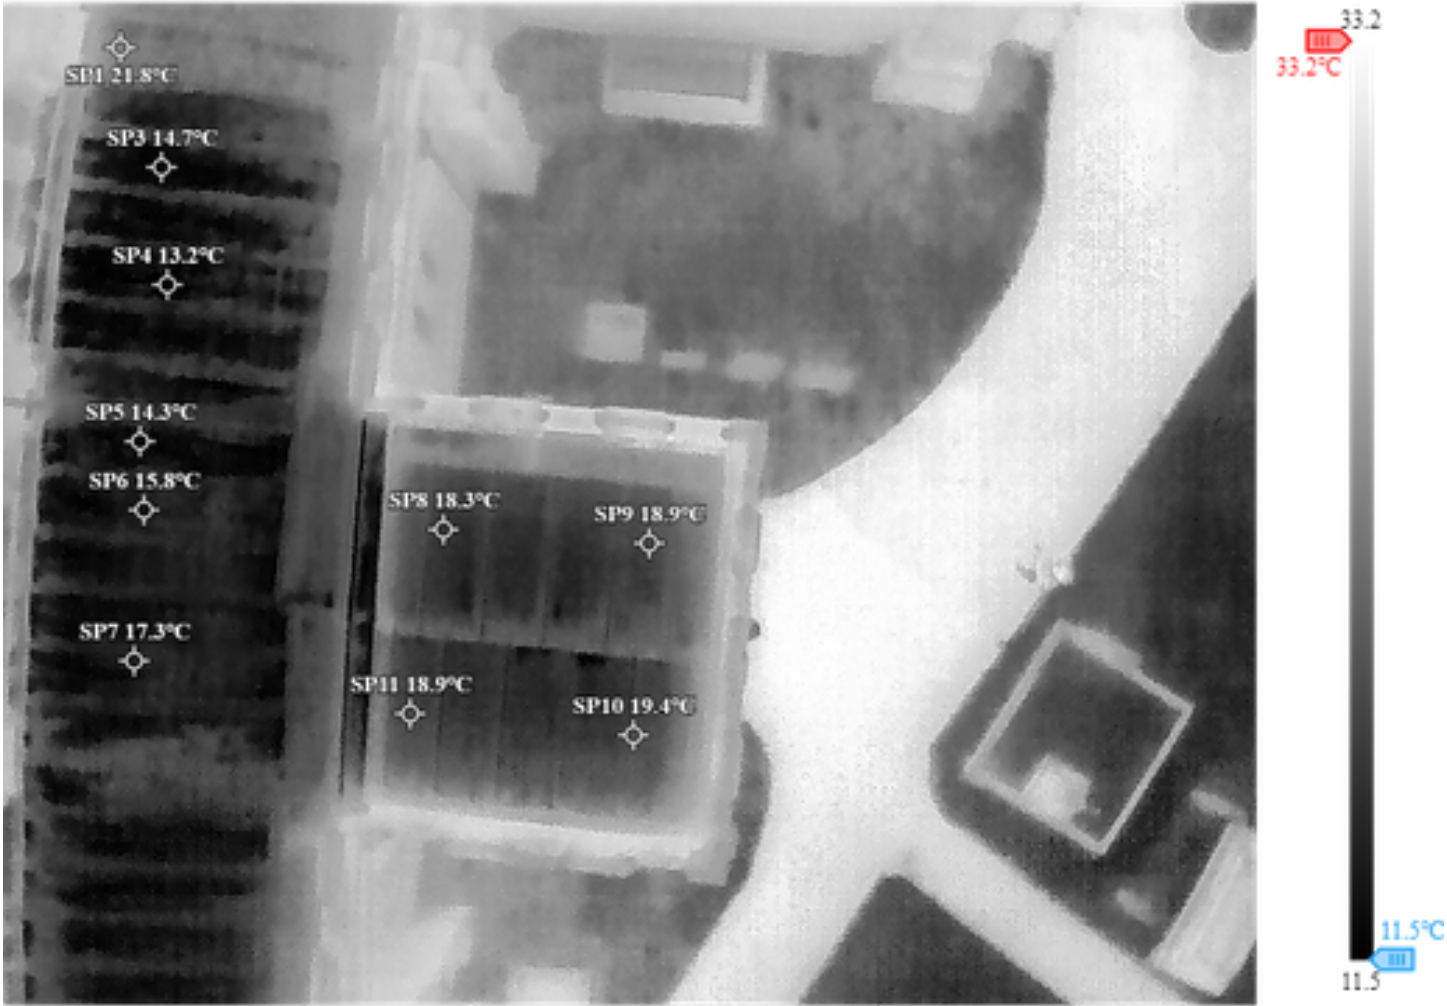
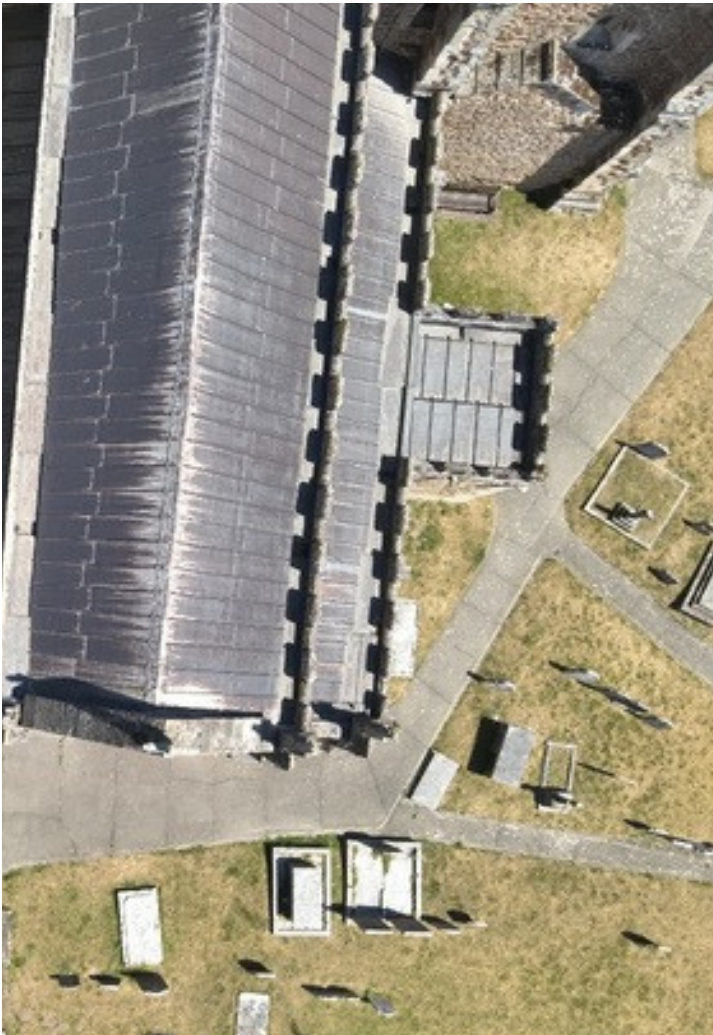
Anomalies identified between survey points SP1/SP11 and the surrounding roof structure, with a maximum observed differential of approximately 8.6°C. This area is recommended for further inspection.

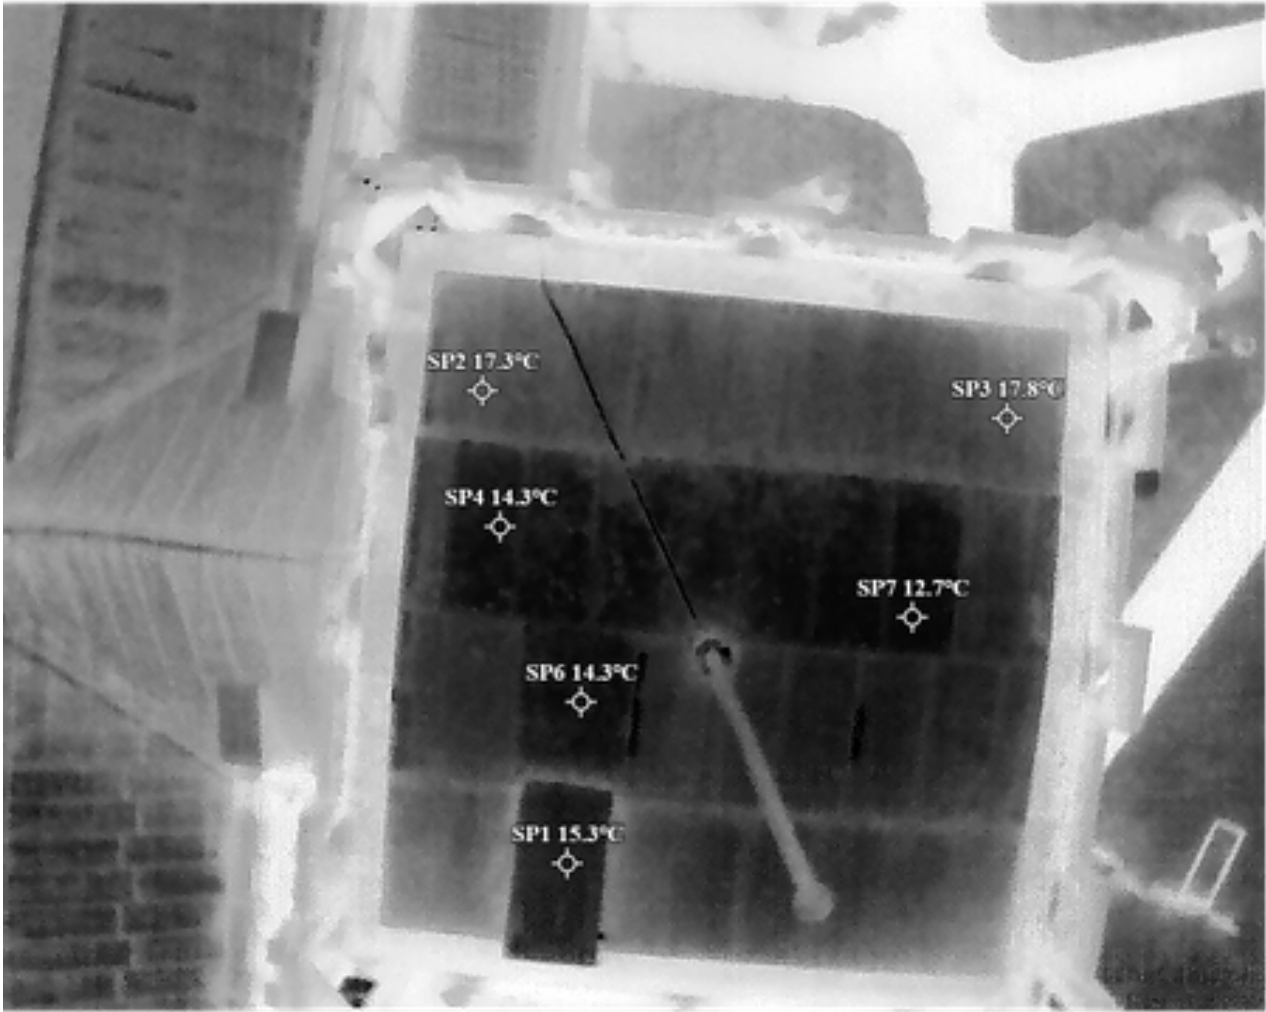
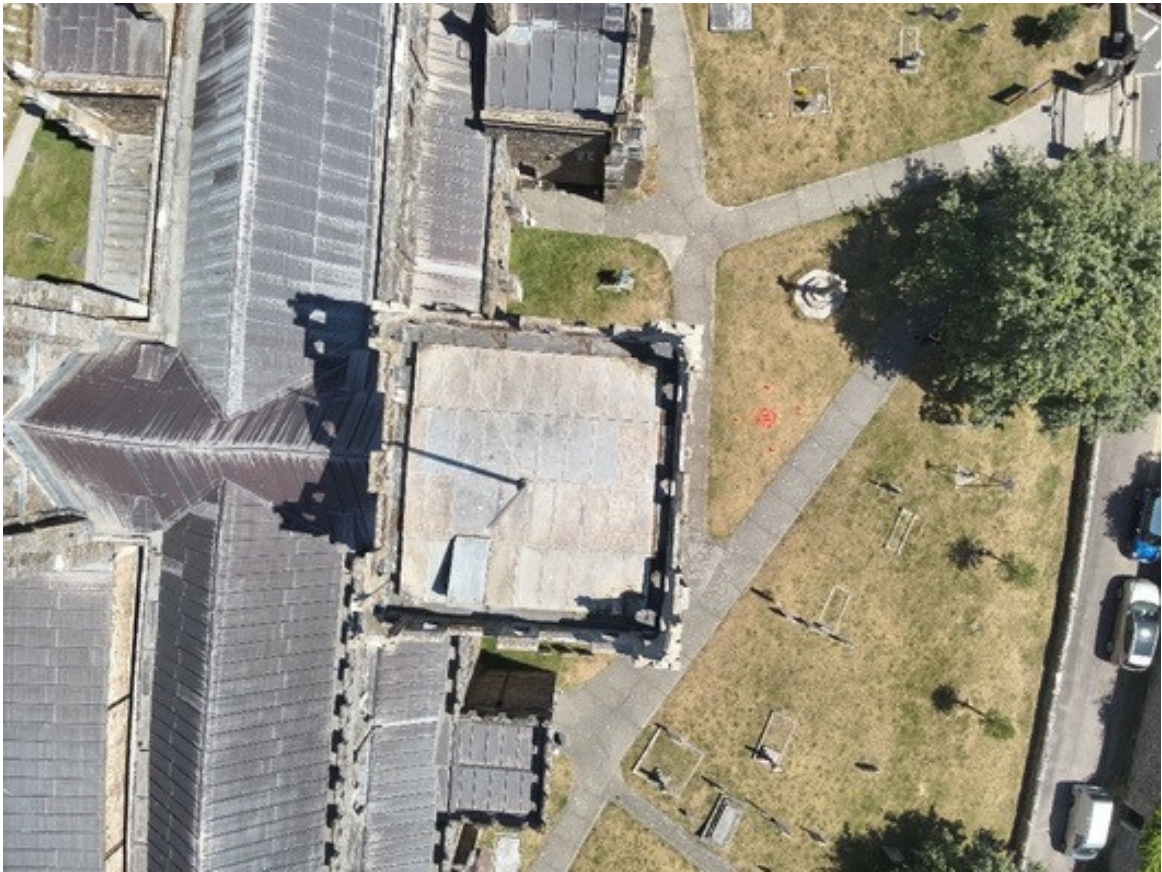
Anomalies identified between survey points SP1/SP7 and the surrounding roof structure, with a maximum observed differential of approximately 4.6°C. This area is recommended for further inspection.

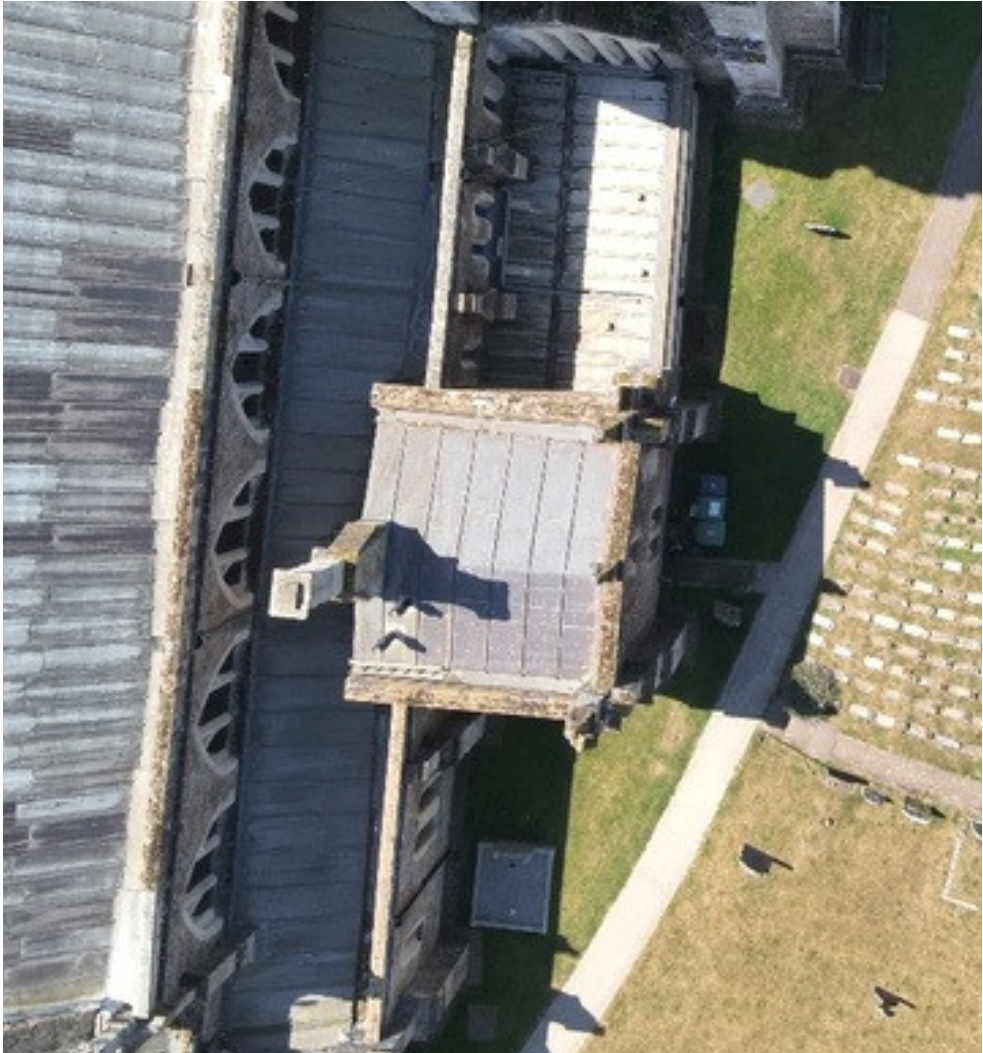
Anomalies identified between survey points SP1/SP11 and the surrounding roof structure, with a maximum observed differential of approximately 8°C. This area is recommended for further inspection.
