# **Junior Aerial Thermal Survey Report**

**URN:** **JA-14072026-0001**

**Client has reported that they are looking to replace the roof of Ottery St Mary Parish Church. Junior Aerial have offered to conduct a thermal roof survey of the property to identify priority areas for inspection.**

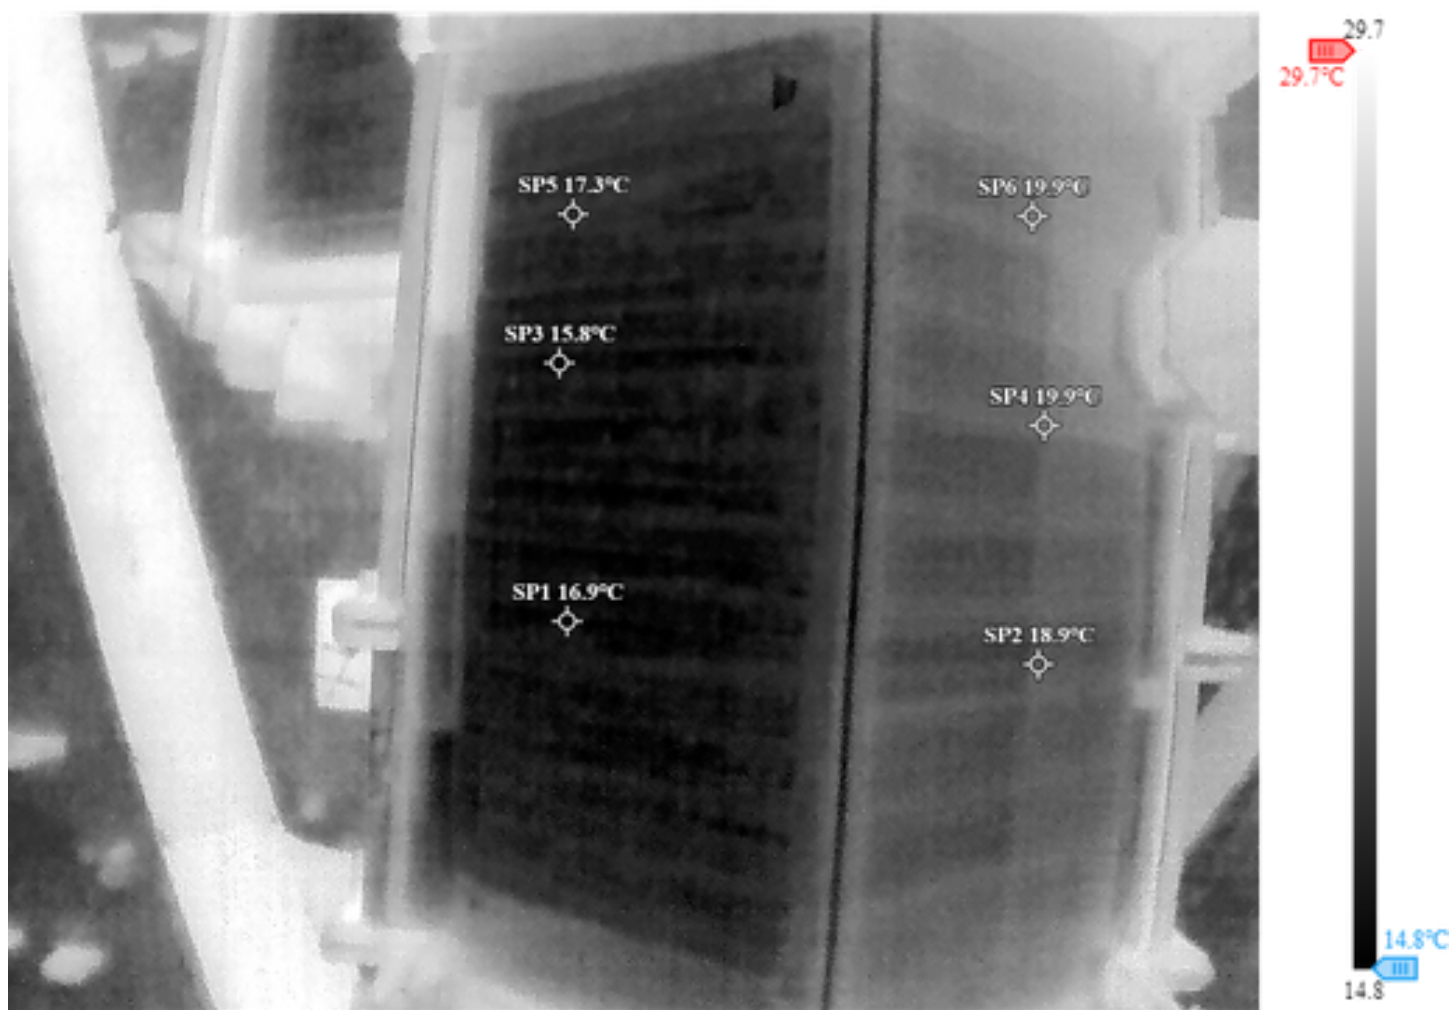
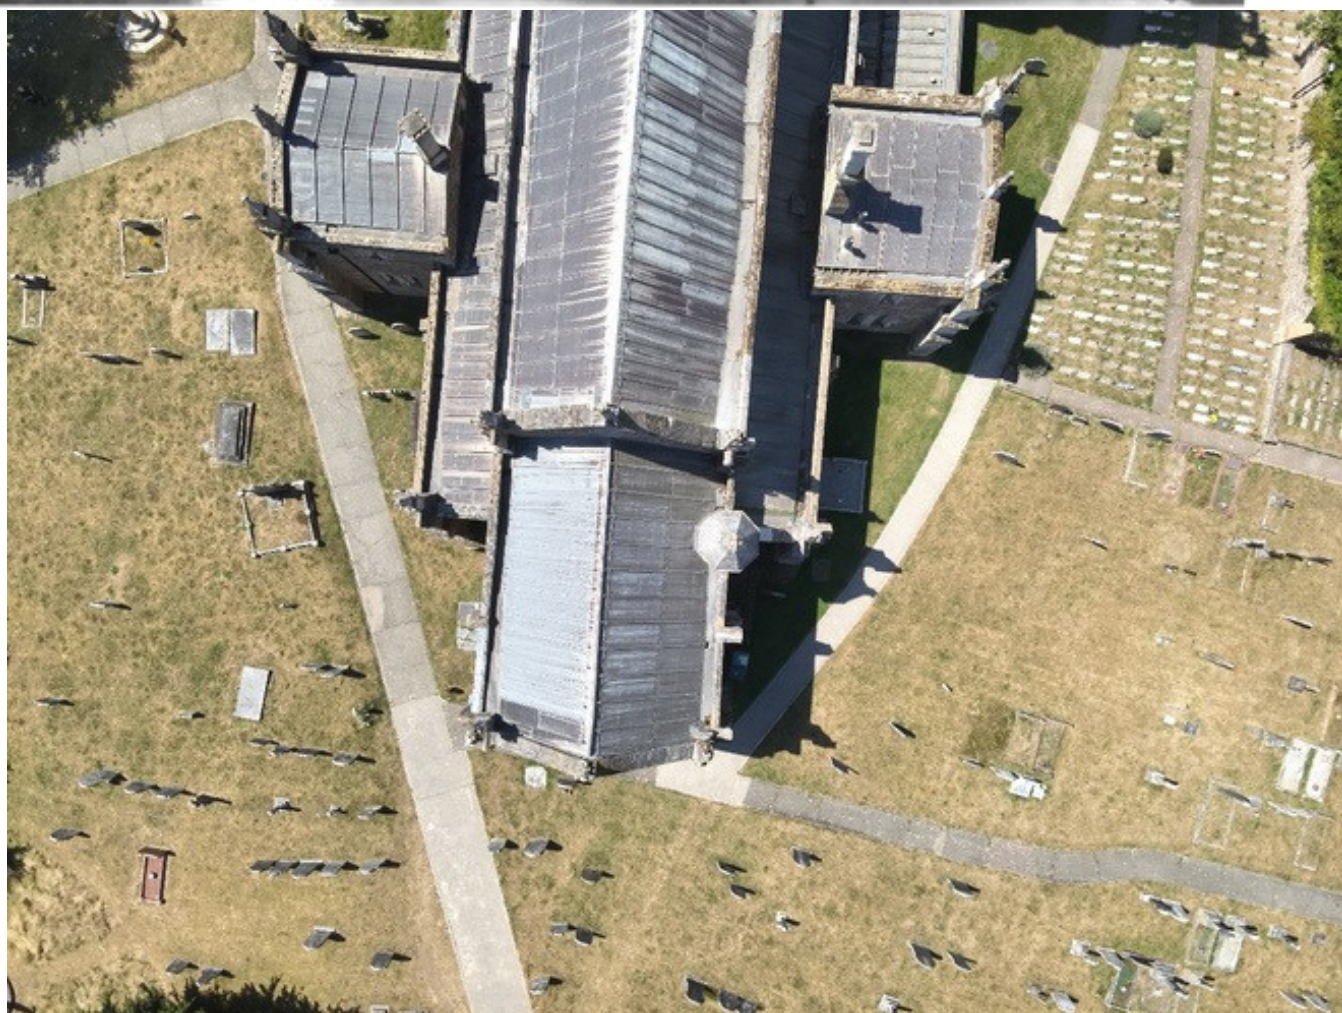
Anomalies identified between survey points SP1/SP7 and the surrounding roof structure, with a maximum observed differential of approximately 4.1°C. This area is recommended for further inspection.

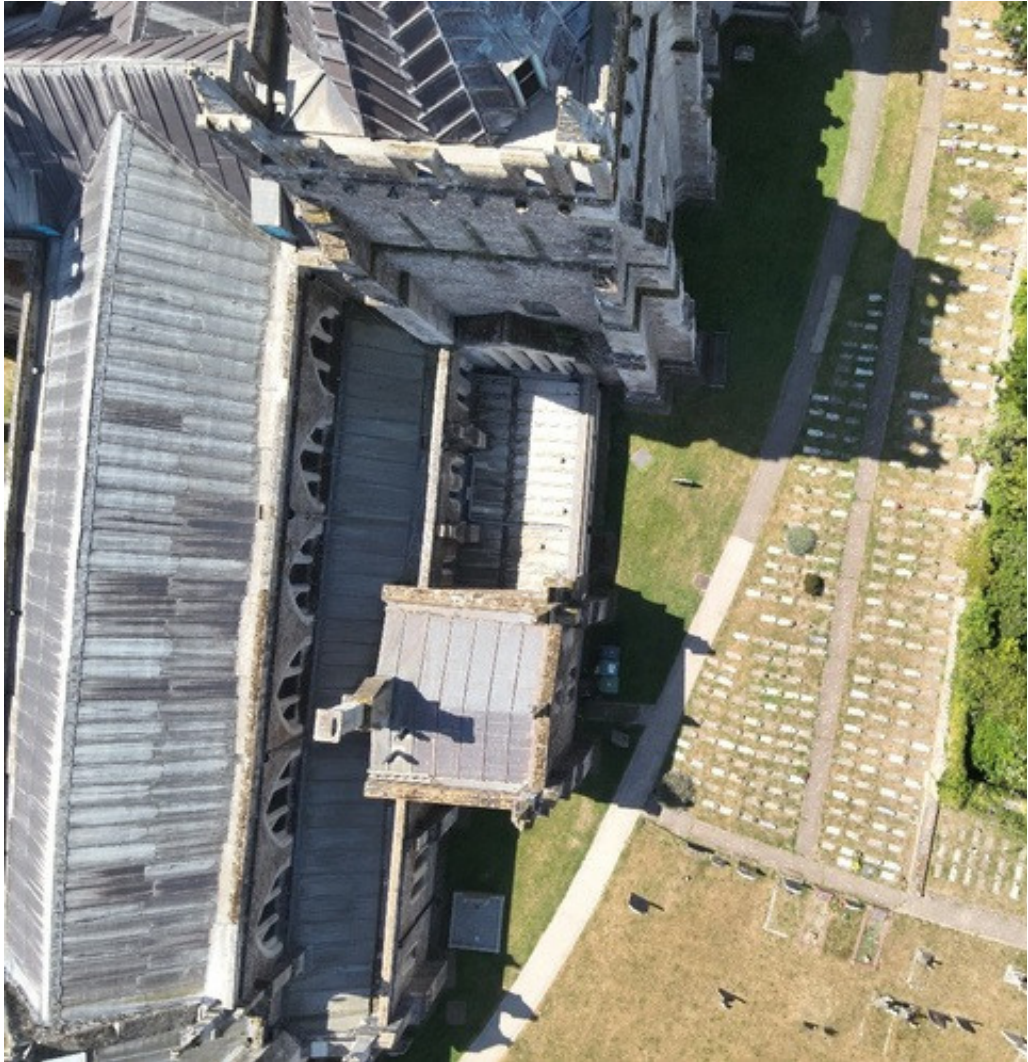
Anomalies identified between survey points SP1/SP5 and the surrounding roof structure, with a maximum observed differential of approximately 8.1°C. This area is recommended for further inspection.
